Document type  
**EIA Scoping Report**

Date  
**March 2025**

Project Number  
**1620016691**

# **NESHION ENERGY PARK ENVIRONMENTAL IMPACT ASSESSMENT SCOPING REPORT**

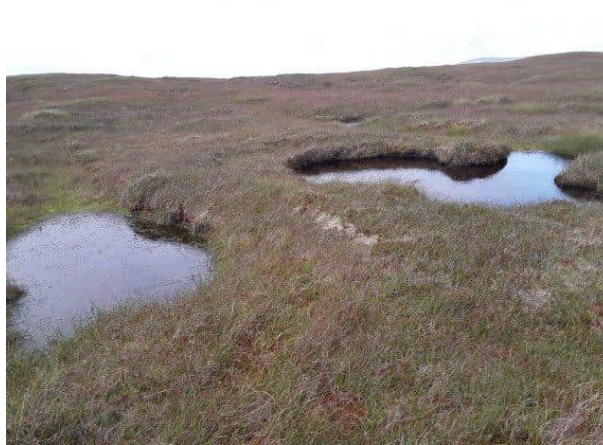
Photo 1: An example of an M2 bog pool in the Study Area.

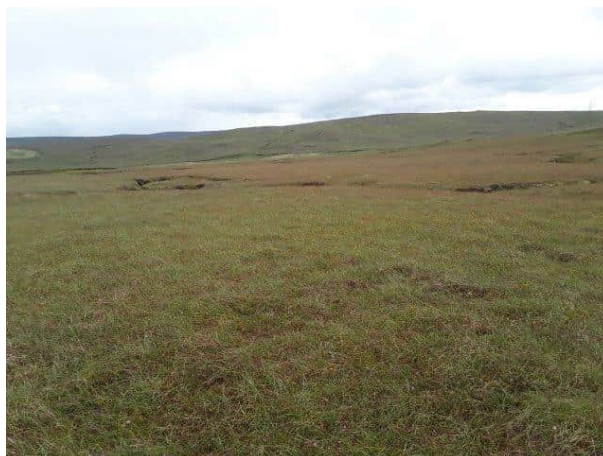
Photo 2: An example of M17 within the Study Area.

The majority of the Study Area was mapped as the blanket bog community M17b. It formed over much of the landscape on hillslopes and on convex and concave surfaces.

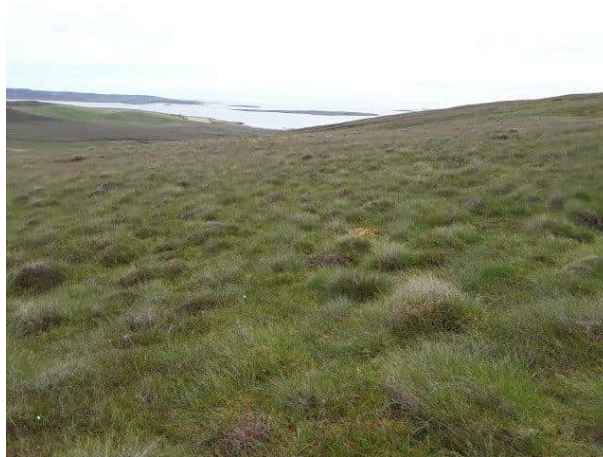
*Photo 3: An example of M19 within the Study Area.*

Much of the M19a blanket bog vegetation was recorded towards the centre of the Study Area, with a notable large area with M2 bog pools in the west. M19a vegetation was also found near watercourses and lochans and as small patches within the wider M17b blanket bog landscape.

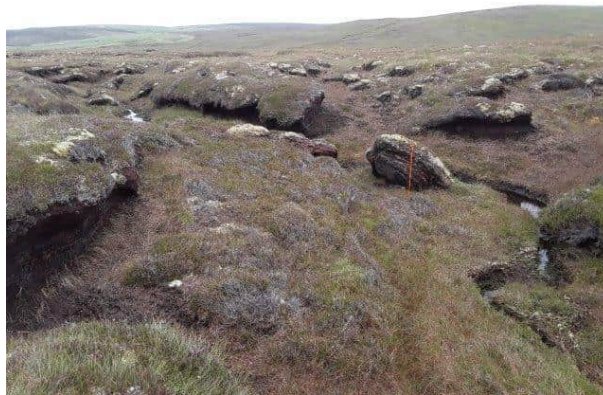
*Photo 4: An example of DMB within the Study Area.*

The dry modified bog was not given an NVC community, but it was clearly derived from M17b blanket bog vegetation and was transitioning to a dry heath vegetation. It was largely dominated by heather with woolly fringe moss often an important and conspicuous part of the vegetation. There was a mix of dwarf shrubs including bell heather, cross-leaved heath and occasionally crowberry. Common cottongrass was frequently present with deergrass. There was a distinct absence of hare's-tail cottongrass. There was occasional round-leaved sundew in isolated wetter areas. Lichens were abundant over the vegetation.

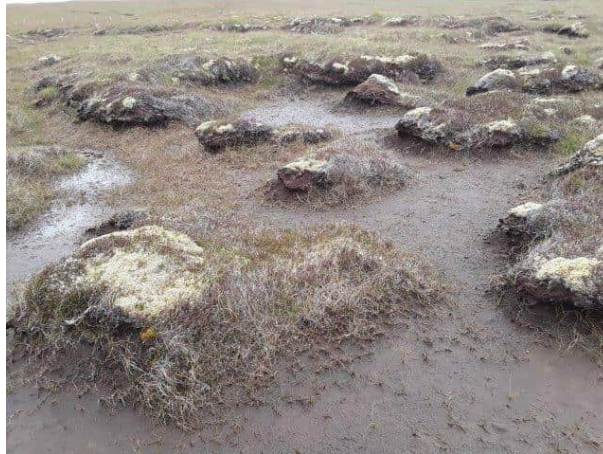
*Photo 5: An example of a M3 bog pool which was largely bare peat with a little common cottongrass in dry modified bog.*

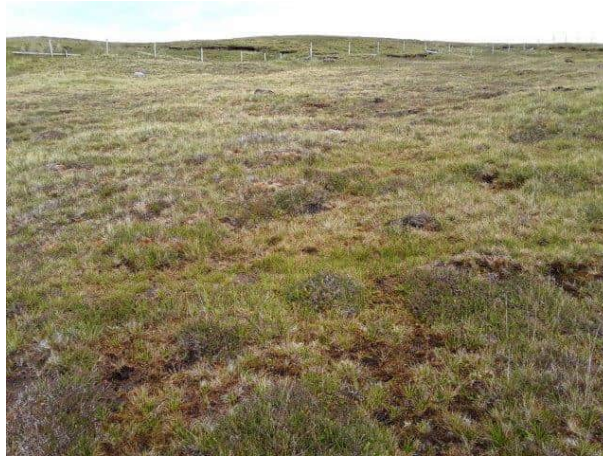
Photo 6: An example of M15c within the Study Area.

The M15c community was on shallow soils to the very north of the Study Area and in the west between Hill of Garth and Sand Water where it appeared peat had been removed through peat cuttings. It was characterised by the typical mix of species including heather, deergrass, common cottongrass, tormentil and cross-leaved heath. The wet heath in the north of the Study Area had a high prominence of heath rush and mat grass with crowberry also present. Lichens and woolly fringe moss typically formed the ground layer with patches of red bog-moss. Rocks were often showing through and there were patches of bare peat.

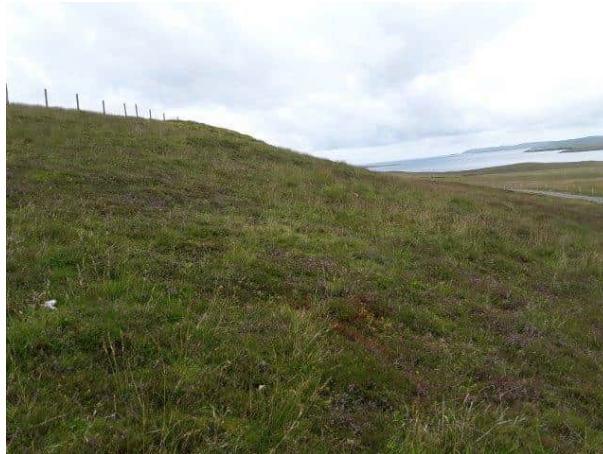
Photo 7: An example of dry heath within the Study Area.

The dry heath was recorded in a large area in the west of the Study Area around Toft, in small patches across the Study Area and as mosaics with grassland and along the steep banks of watercourses. It was dominated by heather, with few other dwarf shrubs present, although crowberry was occasional. Graminoids could be quite abundant including heath rush, purple moor-grass, heath woodrush, sweet vernal grass, Yorkshire fog, mat grass, wavy hairgrass and green ribbed sedge. There was a little tormentil and common mouse-ear. Ragwort was present in the dry heath community when it was close to tracks/roads. The ground layer was usually dominated by glittering wood-moss, with little shaggy-moss frequently present.

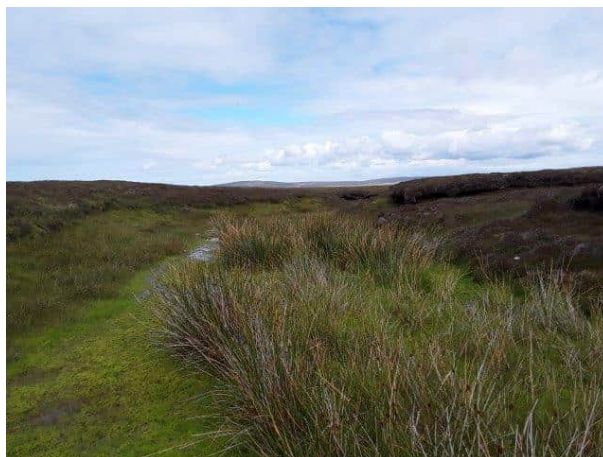
Photo 8: An example of M6b and M6c within the Study Area.

The M6c sub-community is a soligenous acid flush which was occasionally recorded as small lines of vegetation where water flowed down the hillside or as part of larger watercourses. It was dominated by soft rush with sedges much less frequent than the M6b sub-community. Flat-topped bog-moss and common haircap typically formed the thick ground flora. There was also creeping bent, tormentil, Yorkshire fog, and papillose bog-moss.

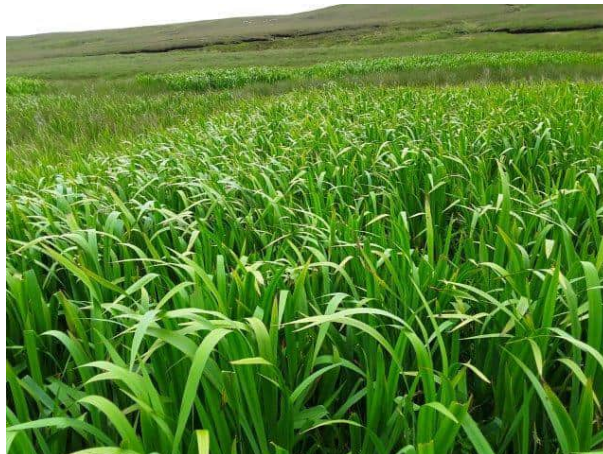
Photo 9: An example of M28 within the Study Area.

There were several stands of the yellow iris dominant mire M28 forming the wet channels of marshy grassland around the croft towards the centre of the Study Area. This was within small drainage channels within the grassland communities. Yellow iris dominated often almost entirely, but there was also some Yorkshire fog, common sorrel, marshy thistle, marsh willowherb and sweet vernal grass.

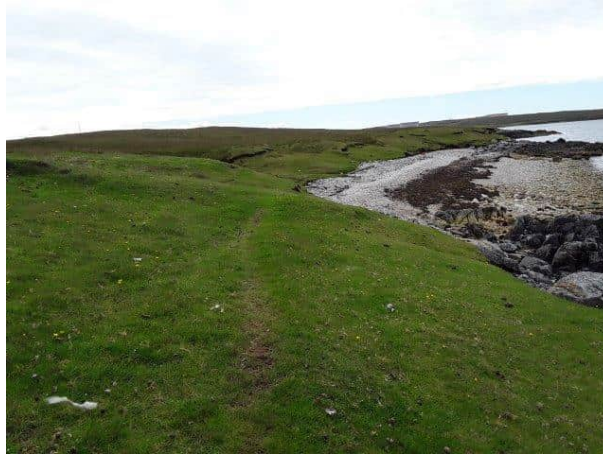
Photo 10: An example of MC10a within the Study Area.

Coastal grassland MC10a was mapped as a small line along the coast at the very north of the Study Area. The coastal grassland was dominated by red fescue and thrift. Buck's-horn plantain and sea plantain were abundant and constant in the sward. Other graminoids included creeping bent, sweet vernal grass, heath rush and mat grass. There was commonly autumn hawkbit and eyebright.

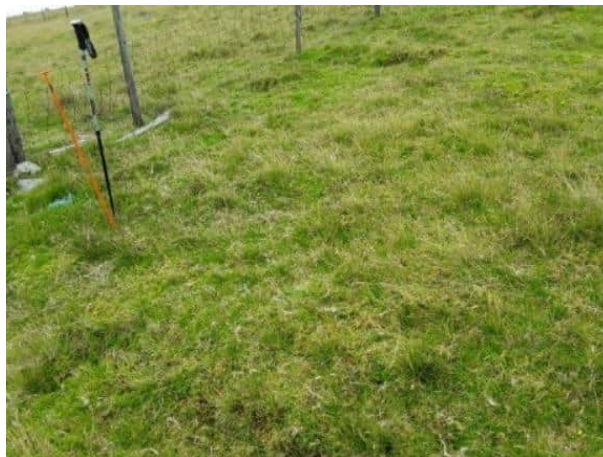
*Photo 11: An example of U5 acid grassland within the Study Area.*

The U5 grassland was dominated by mat grass, with a varying but quite high abundant of heath rush. There was a mixture of other grasses including viviparous sheep's fescue, Yorkshire fog, common bent and sweet vernal grass. Heath woodrush was commonly present. Forbs included tormentil, heath bedstraw, dog violet. There were occasionally patches with heather and marsh thistle. The moss layer was dominated by glittering wood-moss and common haircap in wetter places.

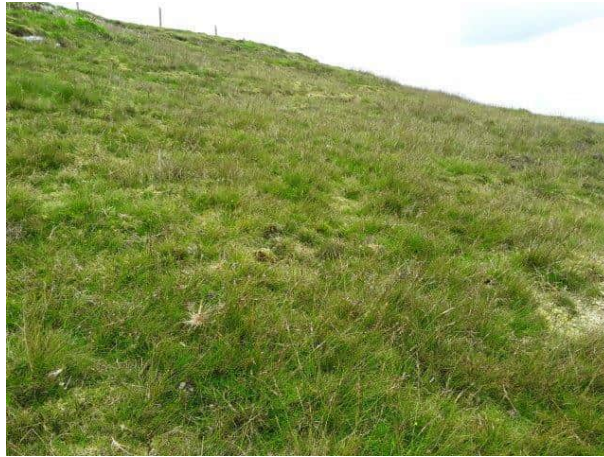
*Photo 12: An example of U6 acid grassland within the Study Area.*

There were small patches of the U6 heath rush dominated grassland across the Study Area. Heath rush was dominant although mat grass could be very abundant in some stands, making it difficult to distinguish between U5 mat grass grassland and U6 heath rush grassland in some locations. However, where heath rush was considered to be dominant, and mat grass subordinate, it was assigned the U6 grassland community.

The U6 grassland community included heath bedstraw, tormentil and a little heather. There were a variety of other graminoids present including wavy hairgrass, sweet vernal grass and heath wood-rush. The moss layer was made up of forked-moss, glittering wood-moss and occasional patches of bog-mosses.

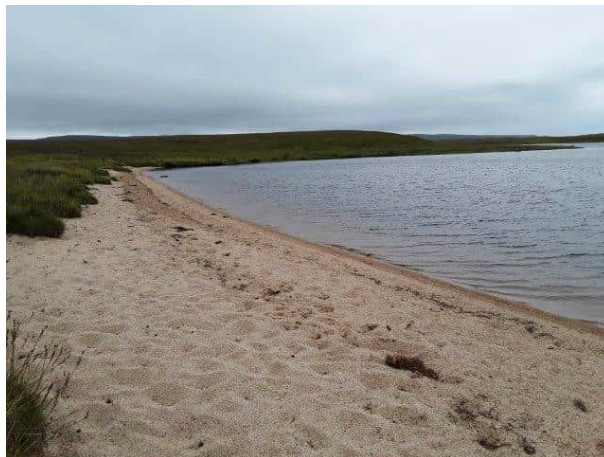
*Photo 13: An example of open water within the Study Area (Sand Water).*

There were several lochs, lochans and pools within the Study Area, including Neshion Water, Sand Water and Loch of Bordigarth. These lochans usually had little to no emergent vegetation within them. The water was generally a peat-stained brown with a stoney and gravel/coarse sand base.

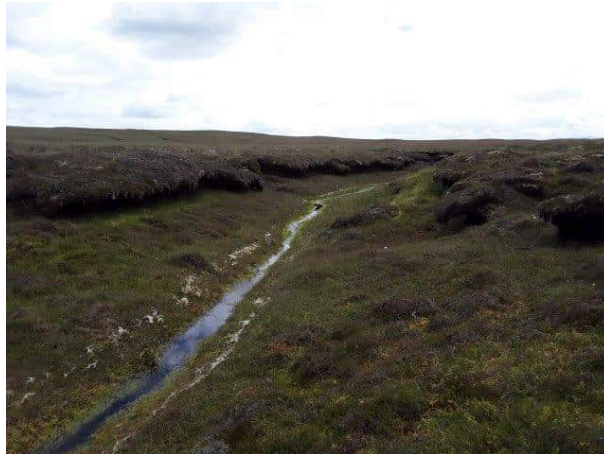
*Photo 14: An example of running water within the Study Area.*

There were several watercourses within the Study Area including the Burn of Crooksetter in the west, and a series of unnamed burns. These watercourses were generally small, less than 1m wide with a rocky or peaty base.

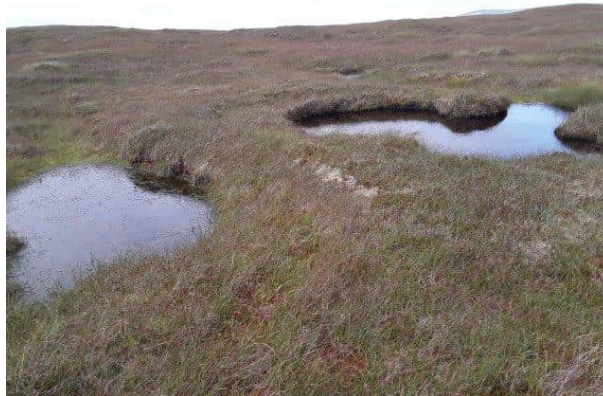
*Photo 15: An example of blanket bog in Near-Natural condition within the Study Area.*

The blanket bog which was considered to be in or approaching a 'Near-Natural' condition contained complexes of bog pools, bog-moss hummocks with a relatively intact bog-moss layer. There was limited sign of drainage. Some grazing impacts were evident.

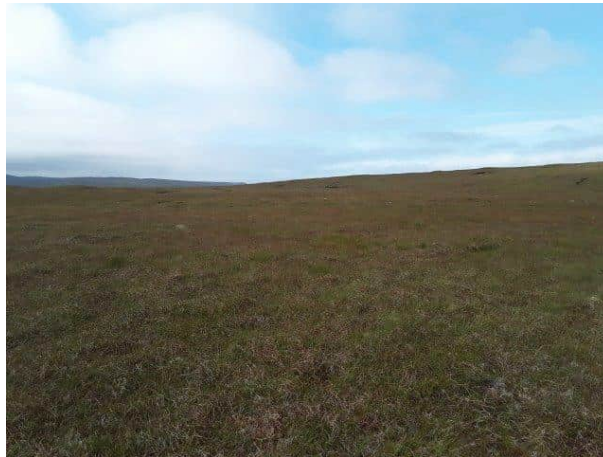
*Photo 16: An example of blanket bog in a Modified condition within the Study Area.*

Most of the blanket bog within the Study Area was considered to be Modified through current and historic management practices, particularly grazing, but possibly also historic burning. The modification was generally quite light with bog-mosses present in the vegetation, but not a complete carpet. Heather and cottongrasses were the dominant species. Bog pools were occasionally present. Some areas had been further modified through historic peat cuttings, and farm/building activities.

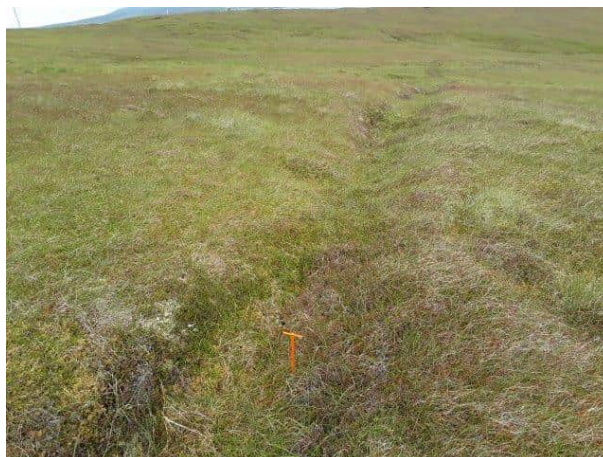
*Photo 17: An example of blanket bog in a Drained condition within the Study Area.*

Drainage ditches were a feature in some parts of the Study Area. Most of the drainage ditches appeared quite old and had vegetation infilling them, but it is likely that there remains some drainage influence. There was ca. 12.2km of drainage ditches mapped within the Study Area. In Figure 4, a 30m buffer has been shown around all the drains demonstrating the area of vegetation which is likely drained by these features. There were also numerous flushes across the Study Area. Some of these were likely historic drains that had fully infilled with bog-mosses and sedges.

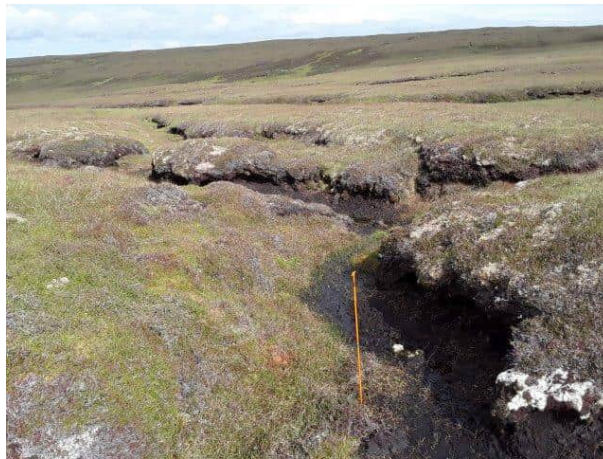
*Photo 18: An example of blanket bog in Actively Eroding condition within the Study Area.*

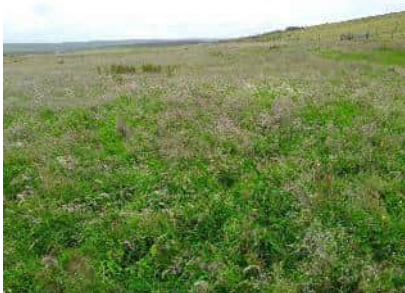
TG	Grid	Comment	Photo
1	HU 43461 76952	MG6 improved grassland for silage or hay. Vegetation was ca. 30cm tall. Mix of rye grass, Timothy, Yorkshire fog, bent grasses and forbs including white clover, creeping buttercup and common chickweed.

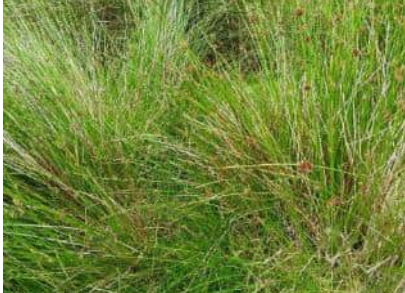
2	HU 43438 76967	Typical MG10a. Soft rush with Yorkshire fog.

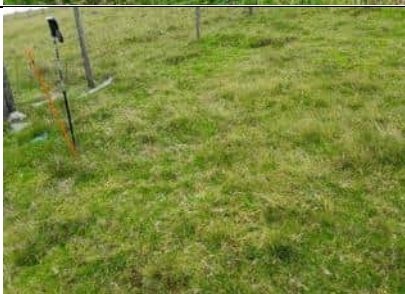
3	HU 43425 76927	Mix of dominance between heath rush and mat grass. The wetter areas were dominated by heath rush (U6) drier areas dominated by mat grass (U5).

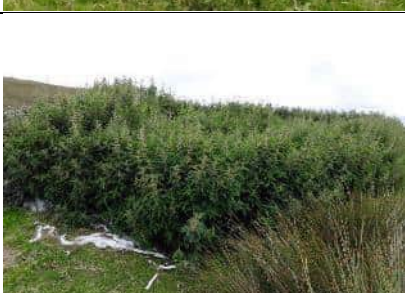
4	HU 43430 76947	Thick patch of nettles (OV24) showing enrichment. Raised area. Likely dump of silage or similar. Area is sheep grazed.

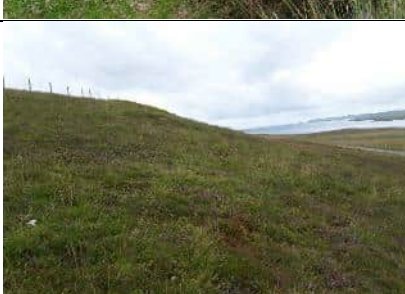
5	HU 43406 76972	Hillside of H10a with abundant heath rush.

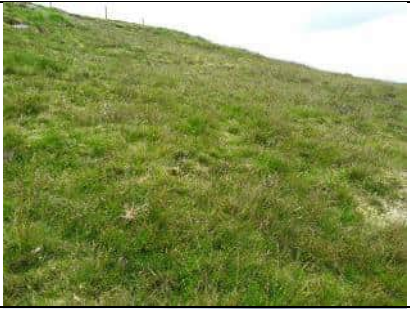
TG	Grid	Comment	Photo
6	HU 43401 77016	Some patches on the dry heath hill slope were dominated by heath rush (U6).

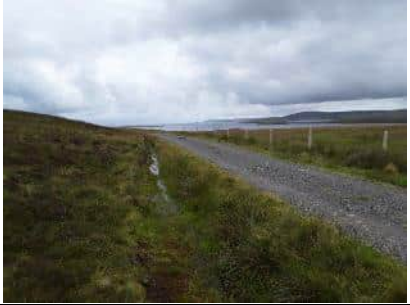
7	HU 43426 77016	Track edge was a mix of MG10a, U6 and U4. There was a ditch (ca. 2m wide) with bulbous rush and creeping bent grass.

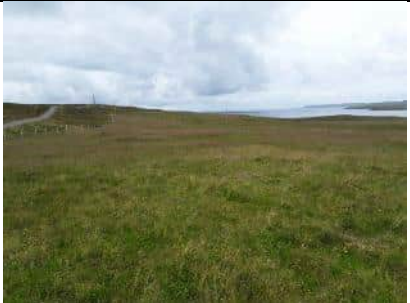
8	HU 43425 77071	Field with U5 in the centre, and U4 around the outside with some clear transition. The U5 was relatively tall.

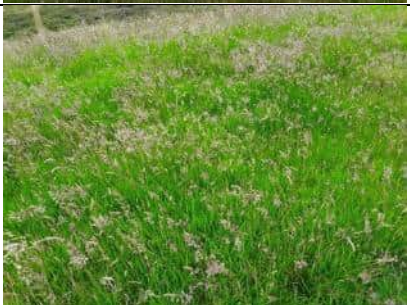
9	HU 43391 77195	U4 dominated area around edges of fields and sometimes beside tracks.

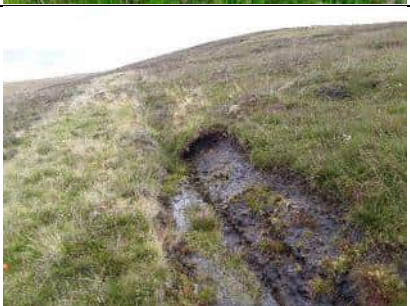
10	HU 43344 77202	Drainage ditch was ca. 1m wide and ca. 20m of it appeared recently re-cut. There was bulbous rush, heath rush and feathery bog-moss in the ditch.

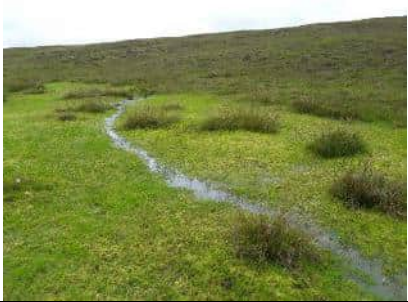
TG	Grid	Comment	Photo
11	HU 43317 77195	Flush/Spring M6b. 100% cover of feathery bog-moss with bulbous rush and some common haircap and flat-leaved bog-moss. There was also common cottongrass throughout the flush. This flush appeared to be on deep peat with a line of flowing water through it.

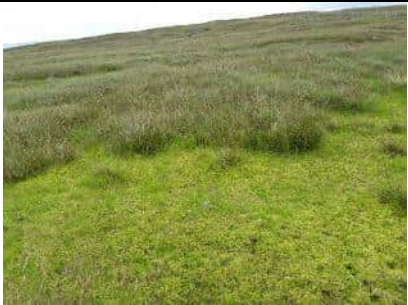
12	HU 43259 77110	At the head of the spring the vegetation was a complex of M6:U6 (50:50).

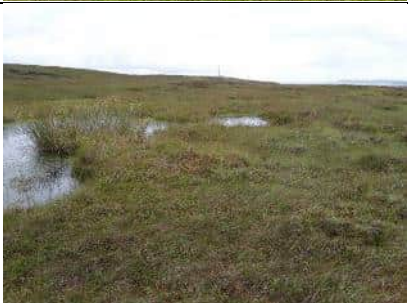
13	HU 43191 77149	M19a:M2:M6b (50:30:20). Complex of pools and wet areas surrounded by M19a blanket bog. Some soft rush present. Clearly grazed but retained some pools. There were occasional hummocks of red bog-moss. Area appears to have resisted grazing damage as so wet. Near-Natural.

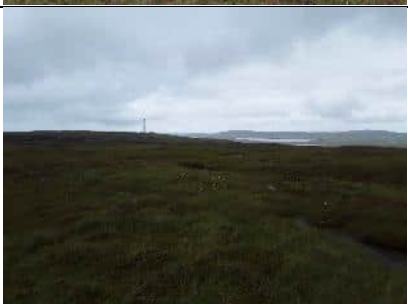
14	HU 42958 77266	M19a:M2. Area has large and small pools. Wet and feathery bog-moss rich. It was clearly sheep grazed, but much less modified than surrounding bog as retained wetness (likely topology related). Near-Natural.

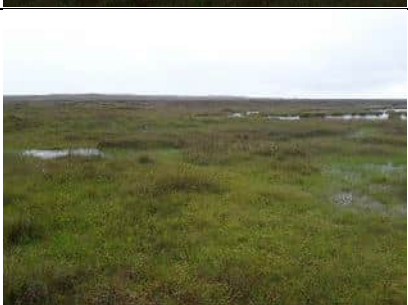
15	HU 42921 77244	M6b dominated by common sedge. In with M2 pools, feeding into lochan.

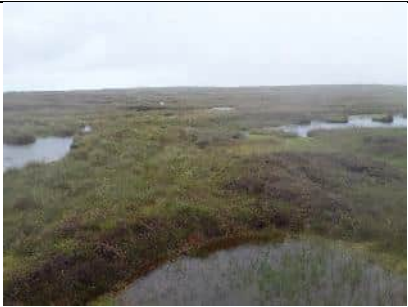
TG	Grid	Comment	Photo
16	HU 42713 77310	Complex of blanket bog, pools, dry heath and acid grassland. Very wet in places with pools. Topography/land-use has resulted in dry heath on higher ground and M2 pools in lower ground. The Pools varied in size from ca. 1m x 1m to 10m x 10m. There was M19a throughout, but also drier patches of U6. Variable peat depth. Near-Natural to Modified condition.

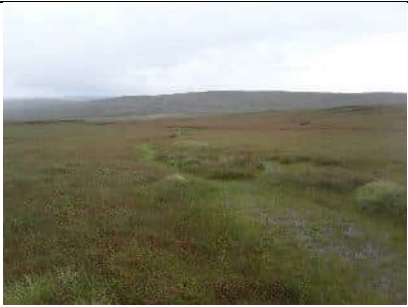
17	HU 42590 77208	Series of M6b flushes going to watercourses. Flushes were 1m to 2m wide. Flushes were dominated by feathery bog-moss, flat-leaved bog-moss with common sedge creeping bent-grass and bulbous rush.

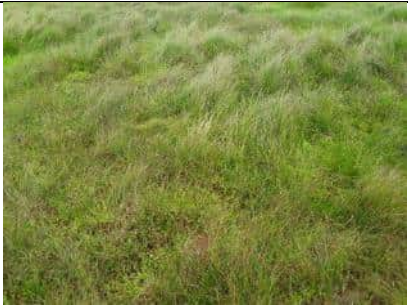
18	HU 42617 77154	Carpet of bog-mosses and common haircap with tussocks of common sedge and heath rush with tormentil. At the transition between dry heath and blanket bog.

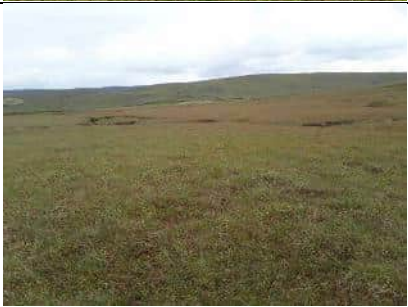
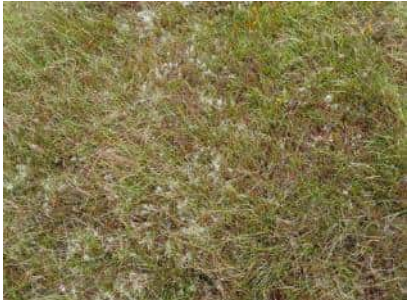
19	HU 42556 77157	M17b vegetation. Bog-mosses present but not a full carpet – patchy. Relatively forb rich. Few bare peat patches. Clearly grazing pressure from sheep. Likely deep peat. No bog-moss hummocks. No pools. Modified.

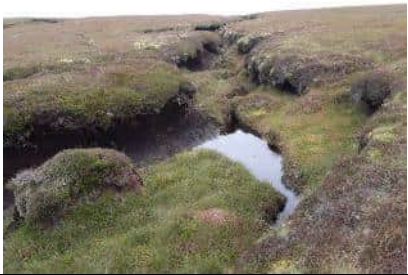
TG	Grid	Comment	Photo
20	HU 42471 77119	Watercourse with ca. 1.5m erosion features to either side.

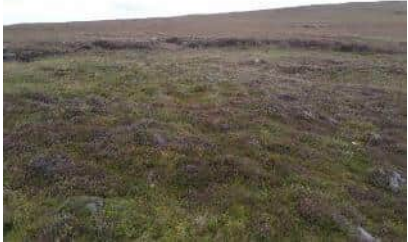
21	HU 42415 77031	Likely old peat cutting. Fully revegetated with H10a but has distinctive shape.

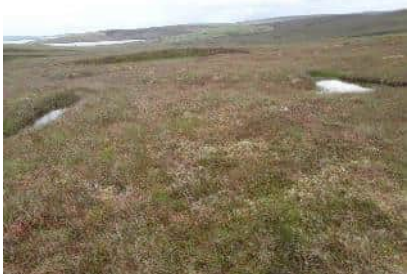
22	HU 42382 77040	Several M2 pools in M17b. Series of pools. There were hummocks of woolly fringe moss. Damp underfoot. Not really bog-moss carpet, except near pools. In low lying areas. Near-Natural.

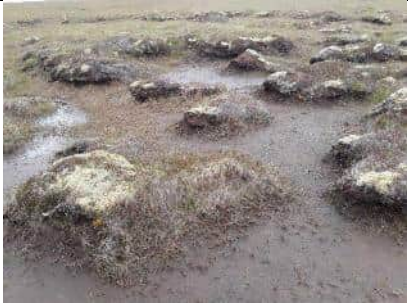
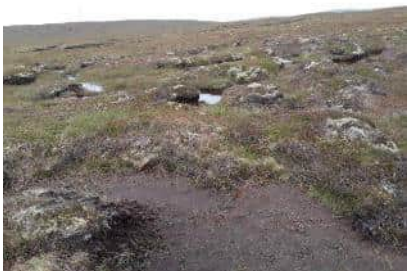
23	HU 42256 77113	Dry modified bog. Actively Eroding. Bare peat with areas of common cottongrass. Clearly historically area had bog pools , which had dried out and lost. Erosion features were ca. 0.3-0.5m deep. M17b:M3:Bare peat 60:20:20.

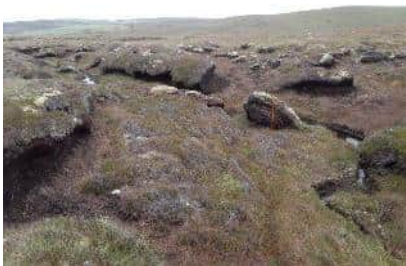
TG	Grid	Comment	Photo
24	HU 42157 77124	Erosion feature was ca. 1.5m to 2m deep. Water flowing at base, likely meets with watercourse. Blocks of peat broken off. Hoof prints and dung from sheep visible. Actively Eroding.

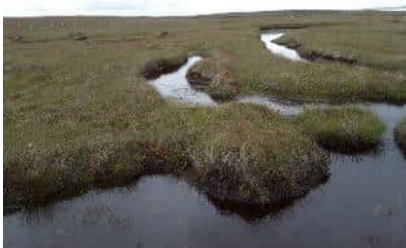
25	HU 42099 77168	Near-Natural blanket bog area with series of pools. M17b:M2 70:30. Potential for these pools to be lost in the manner of surrounding dry modified bog. Currently in Near-Natural condition - Likely actively forming peat, although not full bog-moss carpet. Areas very wet and deep peat. Quaking.

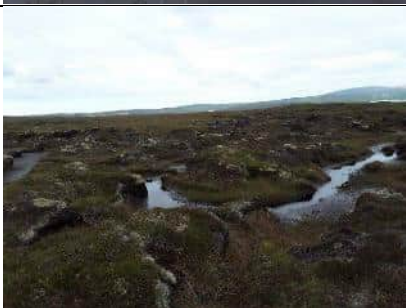
26	HU 42034 77242	These erosion features may once have been pools and lochans lost through erosion and drying out. would likely have been pools and lochans. Potential for HMP work. DMB: M3:bare peat - Actively Eroding.

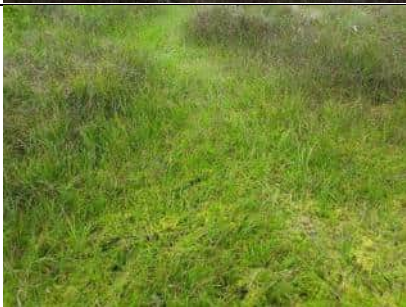
27	HU 41962 77290	M6b flush going though erosion features. Bog-moss carpet, with common cottongrass and common sedge.

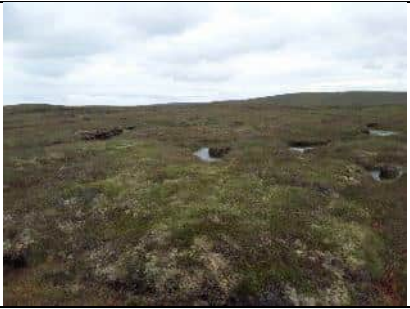
TG	Grid	Comment	Photo
29	HU 41882 77418	Series of pools with M17b bog around it. In danger of being lost through erosion. Large M6b flush beside it. Not full carpet, but hollows and pools (micro-topology). M17b:M2 70:30 – Near-Natural.

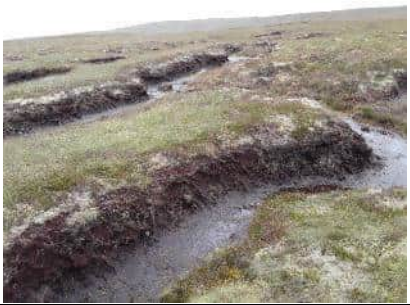
30	HU 41873 77435	Evidence of active erosion which appears to have resulted in lost pools, blocks of peat broken away. DMB: M3:bare peat - Actively Eroding.

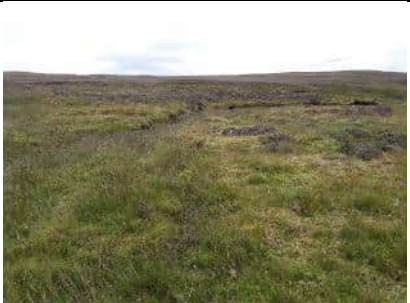
31	HU 41802 77812	Area of U6 were dominated by heath rush appears to be largely on deep peat. Therefore, it was wet modified bog. Low lying dry heath in a bowl. Perhaps an old peat cutting?

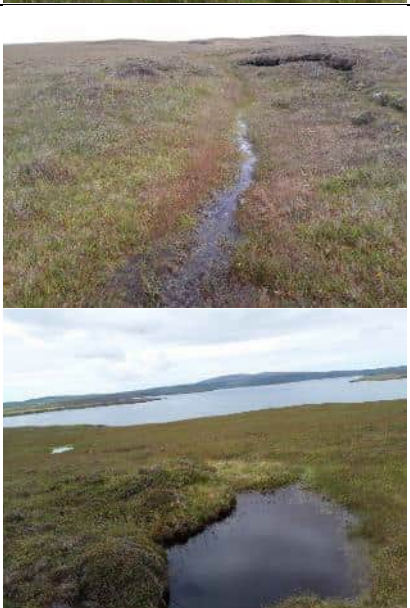
32	HU 41761 77937	Series of M6b flush lines that were often only ca. 1m to 2m wide. Appeared green with bog-mosses and occasional pools.

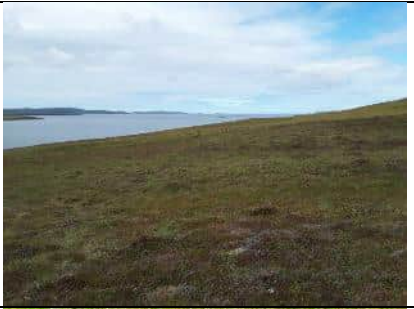
TG	Grid	Comment	Photo
33	HU 41740 78063	Blanket bog was clearly grazed by sheep. There were hoof prints and dung commonly seen.

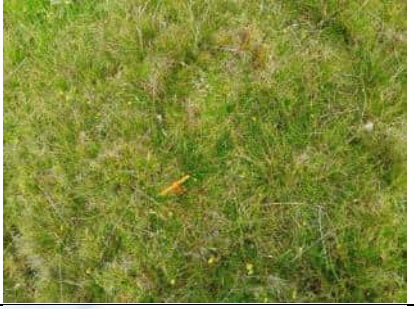
34	HU 41743 78124	U6 on deep peat. Wet modified bog.

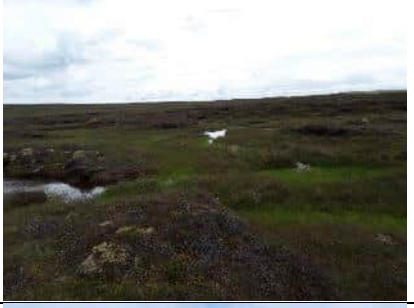
35	HU 41962 78219	This area was dry modified bog, but there were some pools remaining (not all lost). There was also some U6. Appeared to be in the process of being lost and Actively Eroding. Area was Modified with areas Actively Eroding.

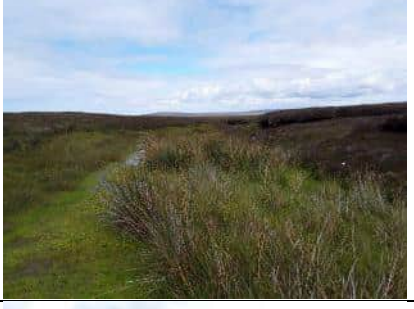
36	HU 42062 78201	Watercourse had a mix of M6b and M6c flush. Stream valley was ca. 5m wide.

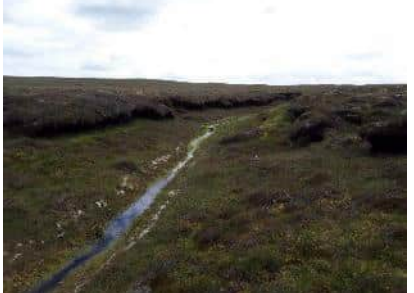
37	HU 42105 78287	The stream valley was made up of H10a:U6:M6b:M6c. There was a line of dead bog-moss after high rains. H10a:U6:M6b:M6c at a ratio of 30:30:20:20.

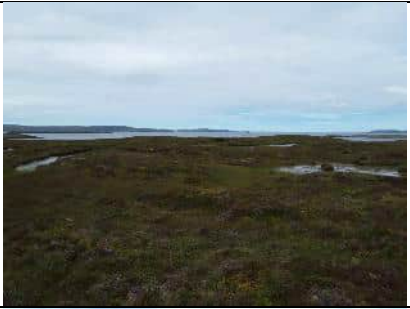
TG	Grid	Comment	Photo
38	HU 42016 78283	Many pools and often wet underfoot. M17b:M2 70:30 – Near-Natural.

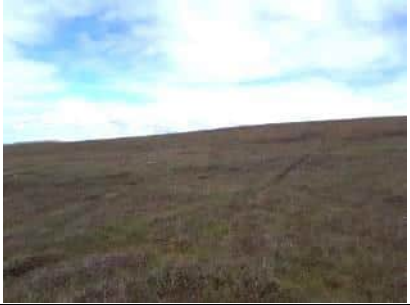
39	HU 41865 78310	Landform looks like old peat cuttings, or slips. Fully vegetated.

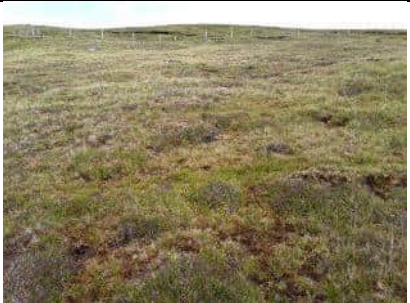
40	HU 41714 78345	Wet heath on shallow soils. Abundant heath rush and mat grass though the M15c community.

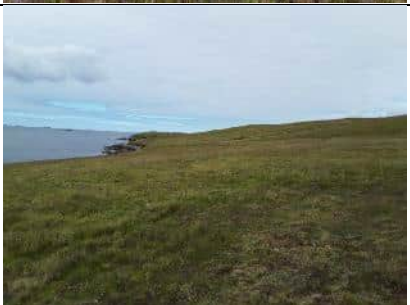
41	HU 41574 78233	Small patch of M17b on deep peat flowing down hillside to sea. Area along coast was largely mix of U5 and U6. Many sheep present.

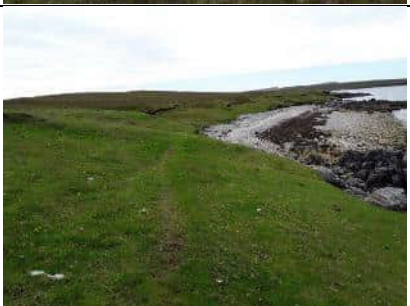
42	HU 41455 78100	Highly cropped coastal grassland MC10a. Heavily sheep grazed. Adjacent to rocky foreshore. Lots of rubbish along foreshore.

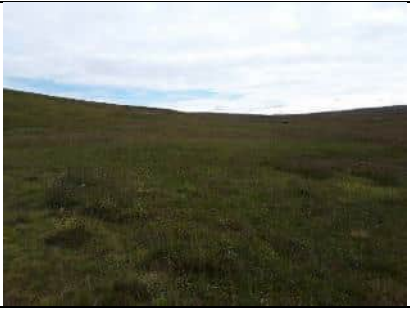
TG	Grid	Comment	Photo
43	HU 41505 78062	Variable peat depth, in old river valley. M15c:DMB:U6 50:30:20. These communities transition in and out of each other.

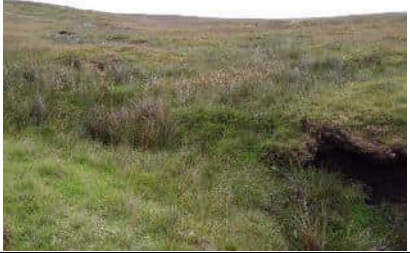
44	HU 41481 77997	MG10a in streambed which was dry.

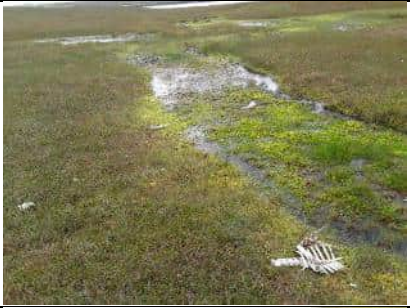
45	HU 41445 77886	Dead sheep, plastic bottles and sheep prints in bog pools. Evidence of Modification in M17b.

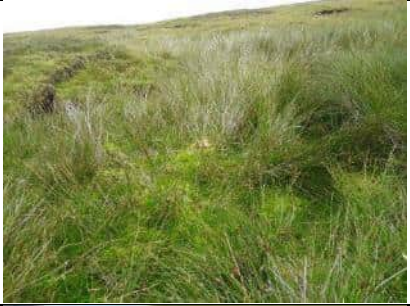
46	HU 41565 77788	Example of M6c flush.

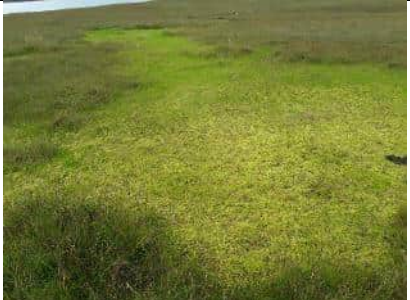
47	HU 41522 77823	Example of M6b flush.

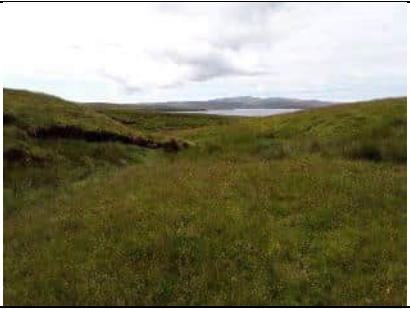
TG	Grid	Comment	Photo
48	HU 41424 77777	MG10a with water flowing. U6 on sides. Sometime H10a on steep sections. MG10a:U6:H10a at a ratio of 50:40:10.

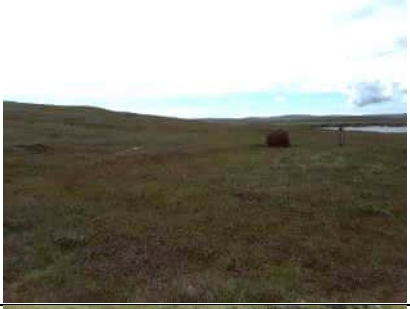
49	HU 41279 77672	Old fence line bailed up. In M17b (Modified). Sheep grazed. Deep peat, occasional M6b flush or M2 pool.

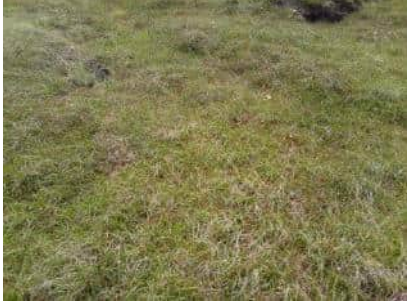
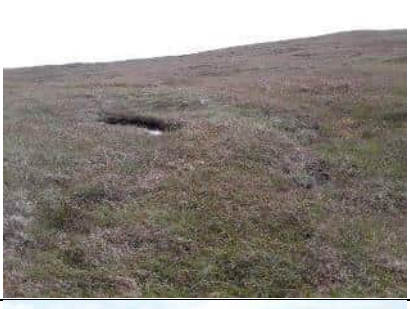
50	HU 41292 77620	Example of M17b relatively lightly Modified blanket bog. Heather and common cottongrass dominated with abundant cross-leaved heath and frequent crowberry, red bog-moss lichens, round-leaved sundew, hare's-tail cottongrass and deergrass. It was often damp underfoot. Sheep present. Few bare peat patches. Occasional bog pools. Bog-mosses were patchy. Woolly fringe moss varied in abundance.

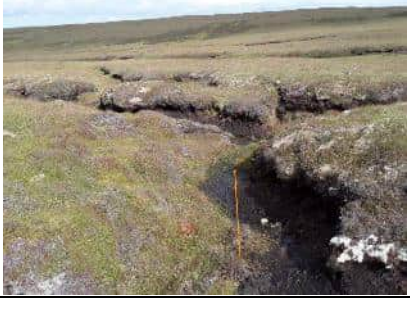
51	HU 41266 77434	Erosion feature. Ca. 1m deep and ca. 50m long. Line of DMB:M3 Bare peat. Actively Eroding.

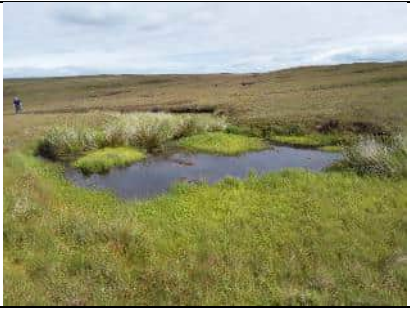
TG	Grid	Comment	Photo
52	HU 41244 77391	Flush as part of watercourse. Mix M6b and M6c 50:50.

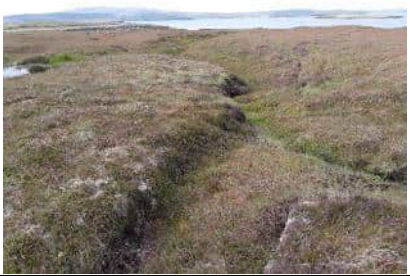
53	HU 41122 77333	Old, largely revegetated, erosion feature with stream flowing through. Modified and Drained around feature.

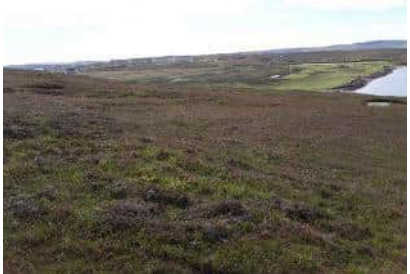
54	HU 41024 77209	View of area beyond boundary fence-line (did not enter) which included a mix of H10a and M17b.

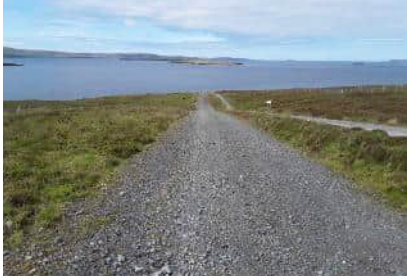
55	HU 41012 77342	Roadside was U4 and H10a.

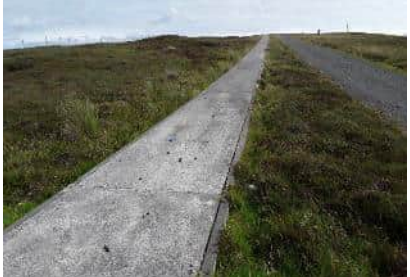
56	HU 41031 77302	1.5 wide concrete line. Likely a pipeline to pumping house. It was ca. 2m from road.

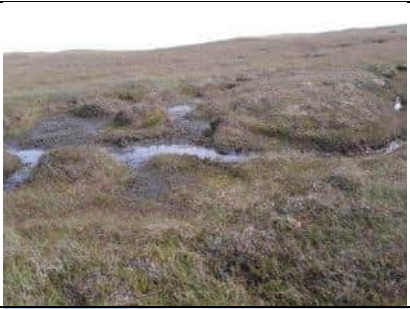
TG	Grid	Comment	Photo
57	HU 41289 77187	M17b had pools which were drying out. Modified. Pools were poached by sheep. Very patchy bog-moss layer. Most pools had little bog-moss within them.

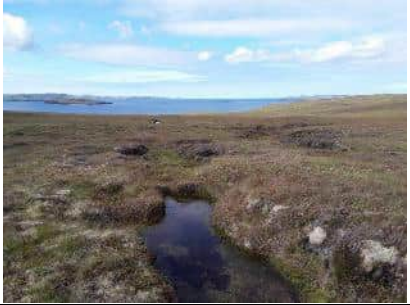
58	HU 41481 77197	Old erosion features well vegetated but with likely water flow and dewatering.

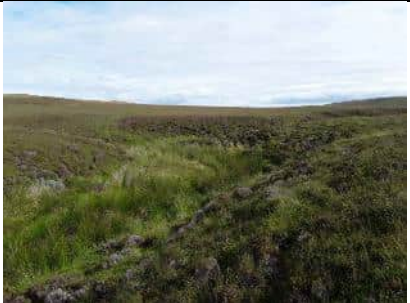
59	HU 41569 77196	H10a with MG10a and U6. Ratio 60 20 20. at base.

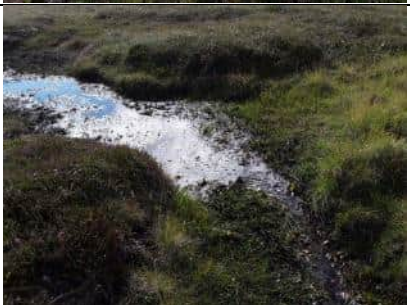
60	HU 41622 77049	M29 characterised by bog pondweed and lesser spearwort. Water trickling through.

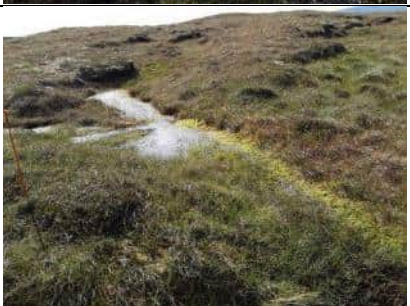
61	HU 41580 76997	At the start of the watercourse there was an M6b flush for ca. 5m then M29 seepage line for ca. 30m.

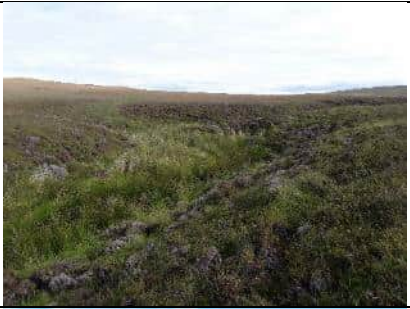
TG	Grid	Comment	Photo
62	HU 41570 76958	M25a beside start of watercourse.

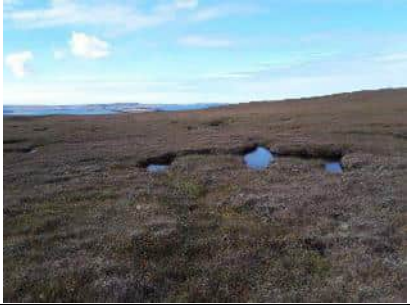
63	HU 41712 76969	Near-Natural blanket bog with bog pools and wet underfoot.

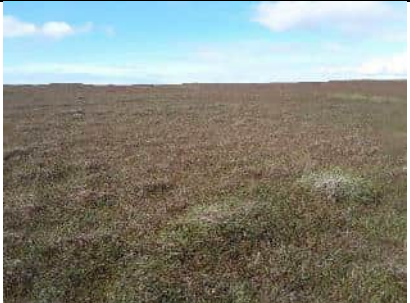
64	HU 42397 77244	Example of M17b relatively lightly Modified. It was generally wet with an intact surface (few erosion features/drains).

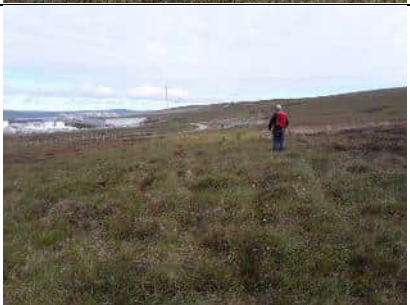
65	HU 41434 75312	Clear line on map. Perhaps fill from old road. Not a different community, but some soft rush in places and M17b was a bit graminoid rich, thicker and taller than usual M17b. Wet modified bog.

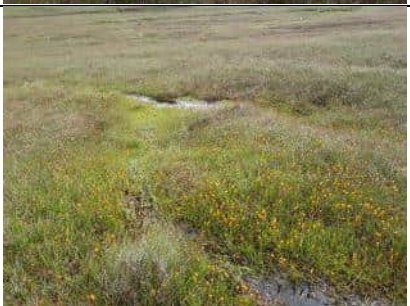
66	HU 41521 75410	Abundant bog asphodel in M6b flush.

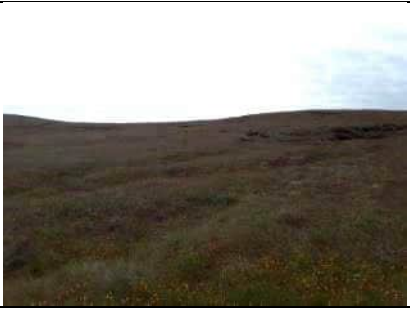
TG	Grid	Comment	Photo
67	HU 41521 75413	Large area of M17b with occasional pools and old erosion features. The occasional old erosion features were partially or wholly revegetated. Modified.

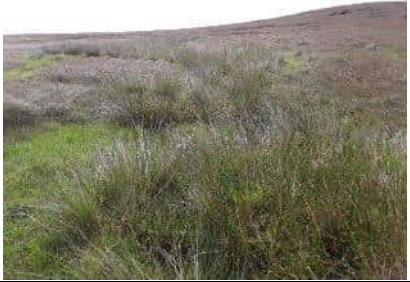
68	HU 41557 75482	Example M6c flush.

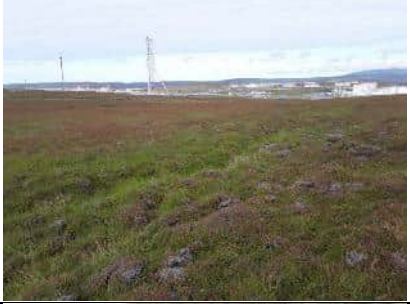
69	HU 41615 75526	H10a with a little acid grassland and occasional flushes going through. H10a:U6 at a ratio of 90:10.

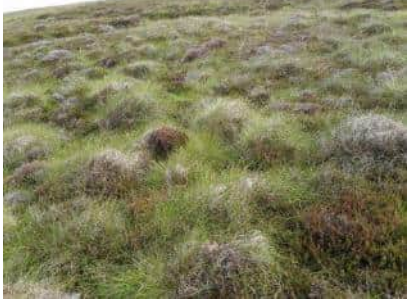
70	HU 41601 75586	Patch of M19a. Very tussocky heather and hare's-tail cottongrass on deep peat at transition of dry heath to the wider M17b blanket bog. Only small area ca. 10m x 20m (not mappable).

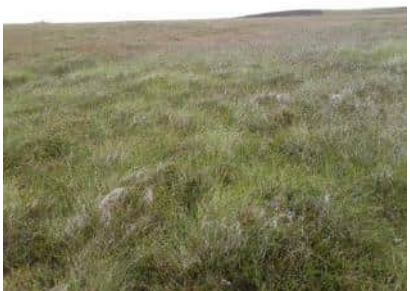
71	HU 41656 75580	On this hill slope there were occasional small (e.g. 5mx5m) patches of M19a mixed in with the M17b. Less than 10% of area.

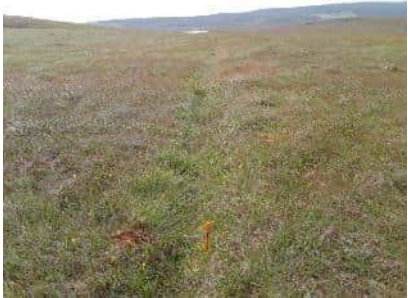
73	HU 41767 75818	Another well vegetated drainage ditch, with only a change in vegetation to mark it out. However, easily pushed pole in. Some drainage likely.

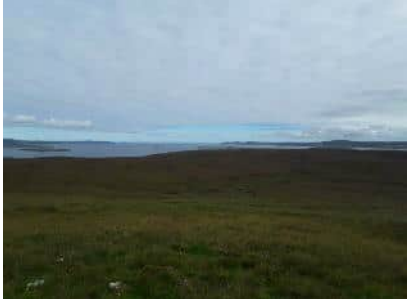
74	HU 41765 75904	View from cairn looking north. Shows extensive blanket bog across Study Area, with mix of conditions including pools, erosion features and drainage ditches.

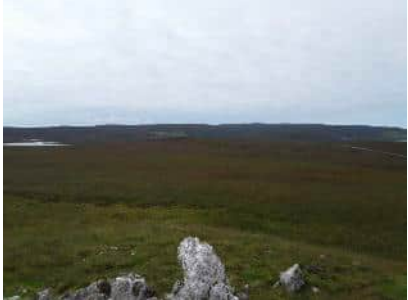
75	HU 41759 75897	View from cairn looking south. View of pools and erosion features in blanket bog vegetation. Area around cairn was of U6 with many rocks.

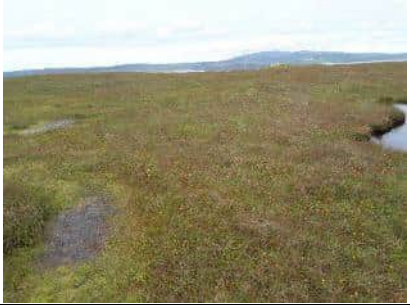
78	HU 41992 75740	Several bog pools in this area with wet bog-moss carpets around pools. Near-Natural M17b:M2 blanket bog.

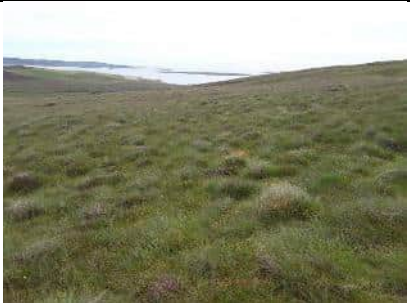
79	HU 41839 75958	Slope of M19a with tussocky of hare's-tail cottongrass, crowberry and heather. Bog-moss present but not abundant. Modified.

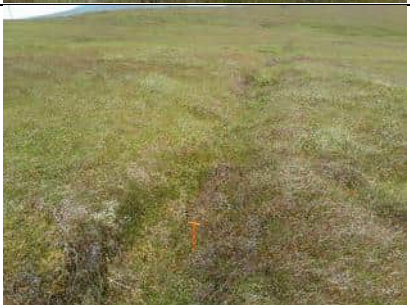
80	HU 41792 76003	Drainage ditch. Ca. 0.5m deep and 0.70m wide. Fully vegetated.

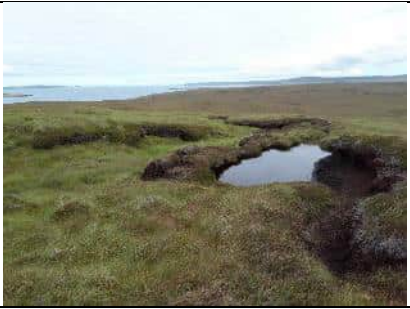
TG	Grid	Comment	Photo
82	HU 41555 76137	Area with a dry modified bog. Clear affinity to M17b and dry heath vegetation. Abundant bell heather and woolly fringe moss. Exposed peat edges were ca. 1m deep. There was usually ca. 1m wide exposed bare peat at base of features. DMB: M3:BP:M17b at a ratio of 50:30:10:10.

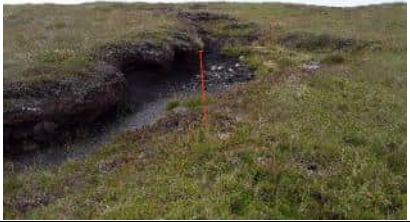
83	HU 41472 76285	Several erosion features running down slope which could be blocked and reprofiled. They were ca. 1m deep and ca. 20m long.

There is a great deal of potential for peatland restoration within the Study Area, particularly in the form of drainage ditch blocking and restoration of areas that were in an Actively Eroding condition. Blocking the drainage ditches and blocking and reprofiling erosion features would help to re-wet the peatland habitat and help to establish a more natural drainage pattern. This would benefit not only the vegetation but the numerous species that depend upon it such as invertebrates and wading birds. Peatland restoration should be explored as part of a habitat management plan should the Proposed Development proceed.

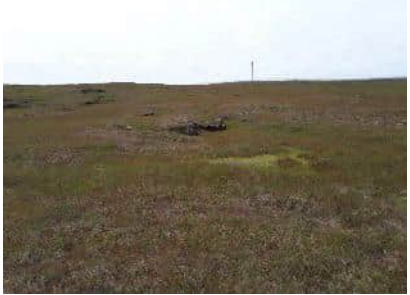
85	HU 41567 76576	Erosion features bring water downhill and feed wetter area at base of hill slope.

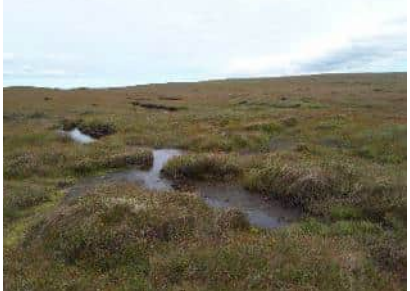
86	HU 41713 76545	Basin with Near-Natural blanket bog. There were several M2 bog pools and the bog was wet underfoot.

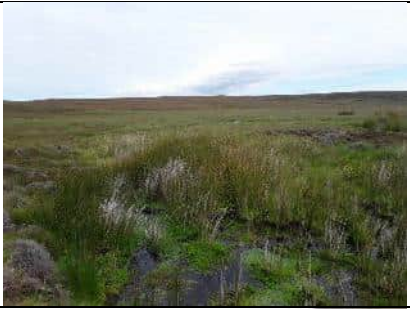
TG	Grid	Comment	Photo
87	HU 41841 76356	M6c forms much of watercourse at this location. H10a dry heath and U6 acid grassland above and to side.

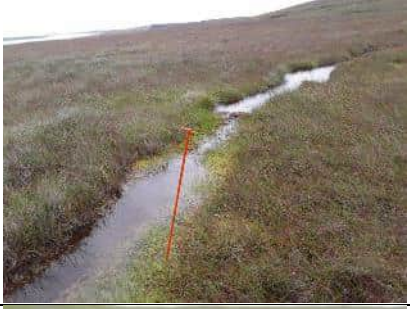
88	HU 41955 76411	Water filled drainage ditch with feathery bog-moss. No pools, but wet M17b blanket bog. Ineffectual drainage ditch.

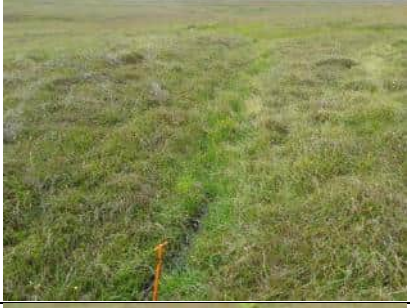
89	HU 42058 76370	Sluggish watercourse/flush of M6b still at this location included several sedge species including common sedge and star sedge. Biofilm present. Likely the flushes here were once drainage ditches.

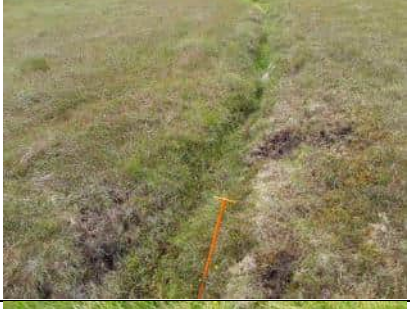
90	HU 42067 76349	Drainage ditch with some M6b.

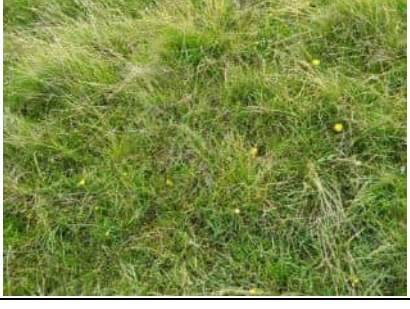
91	HU 41997 76330	Small patch (ca. 10m x 10m) M25a wet modified bog. Included autumn hawkbit, hare's-tail cottongrass, common sedge, common bent, bog asphodel, tormentil, and Yorkshire fog.

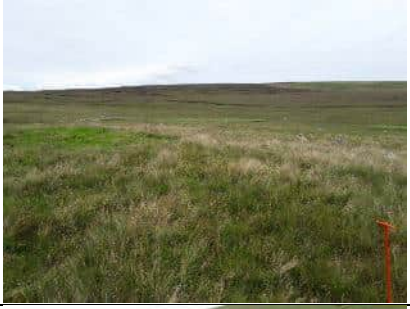
93	HU 42396 76367	Area around old croft buildings was a mix of acid grasslands. U4 showed signs of enrichment around the buildings. There was U6 in wetter areas and U5 in drier areas. U6:U5:U4 at a ratio of 50:30:20.

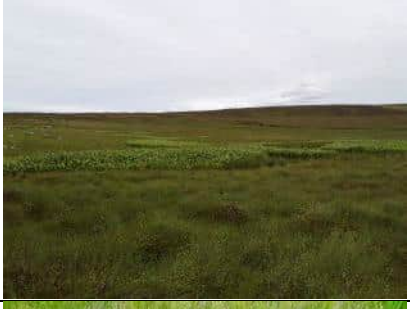
95	HU 42445 76300	View of heavily drained area below old croft. Mix of M28 iris and MG10a (50:50).

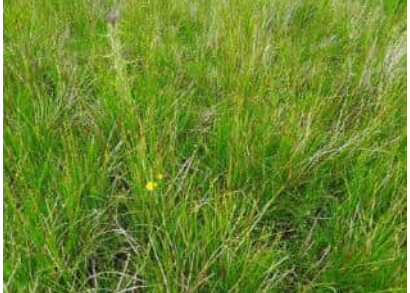
96	HU 42472 76323	Water-logged ground dominated by soft rush and abundant Yorkshire fog. MG10a.

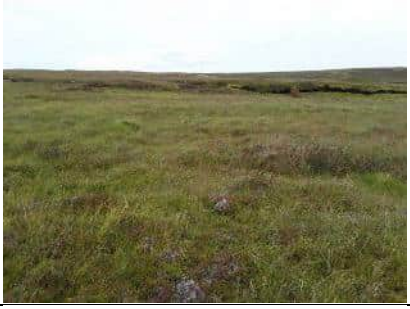
98	HU 42296 76818	This area may have been old peat cuttings from the croft. Generally lost sharp edges of peat cuttings, but there were upper and lower areas with a mix of M17b, M19, U6 and H10a depending on slopes/position (60:20:10:10).

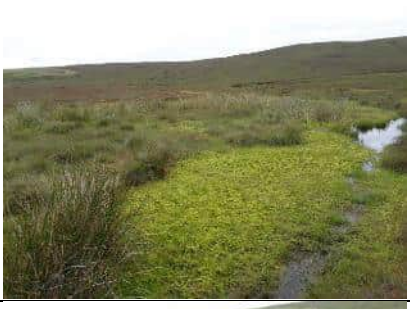
100	HU 42770 76537	Flush of M6c and M6b surrounded by M17b. There were many M6 flushes in this area similar to this one. Perhaps old drainage ditches?

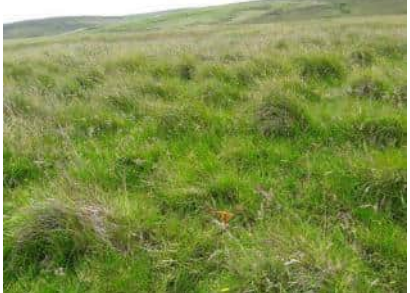
101	HU 43041 76535	A form of U4 grassland on deep peat. Heavily grazed, Yorkshire fog dominated. Wet modified bog.
