Document type  
**EIA Scoping Report**

Date  
**March 2025**

Project Number  
**1620016691**

# **NESHION ENERGY PARK ENVIRONMENTAL IMPACT ASSESSMENT SCOPING REPORT**

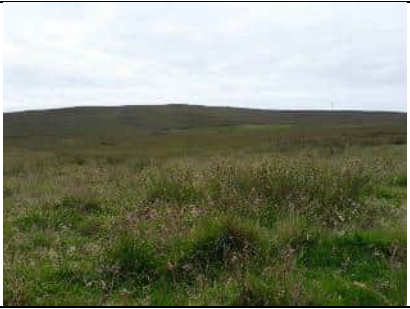
TG	Grid	Comment	Photo
102	HU 43071 76686	View of croft, can see clear lines from peat cutting and drains from crofting practices.

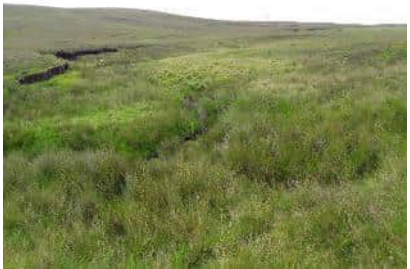
103	HU 42903 76223	Watercourse widens. Mix of MG10a:U6:U5 at a ratio of 50 30 20. Marsh marigold was in the water.

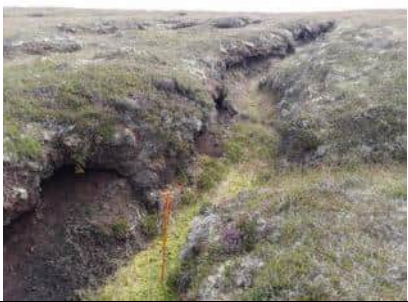
108	HU 42719 75331	Dry modified bog with M3 and Bare peat and some wetter M17b at the bases. There was clearly active erosion, but also some signs of recovery in places with occasional pools. Features range from ca. 0.3m to 1.5m in depth.

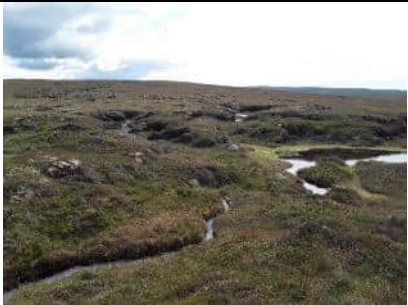
109	HU 42798 75144	Large erosion features ca. 2m to 3m deep. Base was wet from recent rains. Likely bare peat in drier conditions.

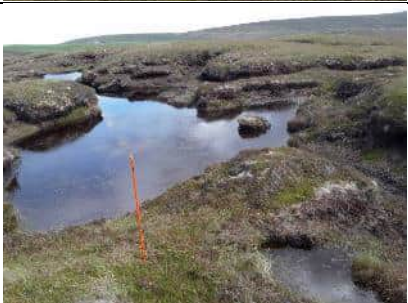
110	HU 42911 75054	Many M2 pools in this area of M17b. There were also lawns of bog-moss and occasional small bog-moss hummocks. Retained high water table. Near-Natural.

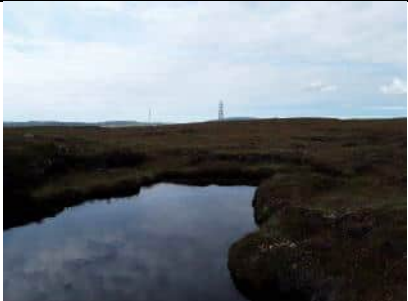
115	HU 41365 75591	Did not enter beyond fence. Viewed watercourse valley. H10a with MG10a and U4. Ratio 50:40:10.

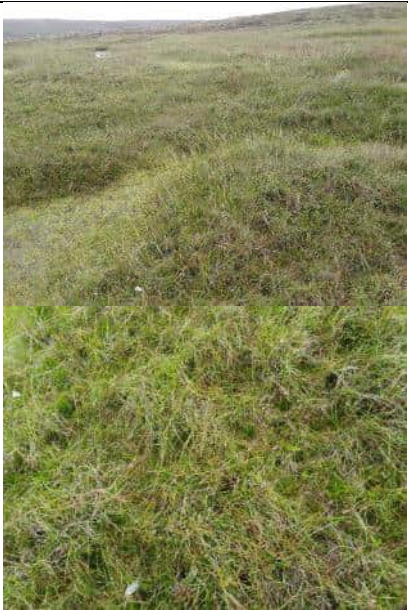
122	HU 41363 73956	Ca. 1m deep peat cutting. U6 at base. Large area of peat removed. M17b and M15c in recovered areas depending on peat depth. Largely M15c.

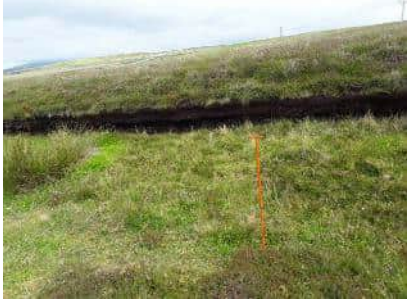
123	HU 41398 73954	Drainage ditch. Well vegetated. Not cut recently. Ca. 0.2 dip in ground surface, but no clear effect on surrounding habitat.

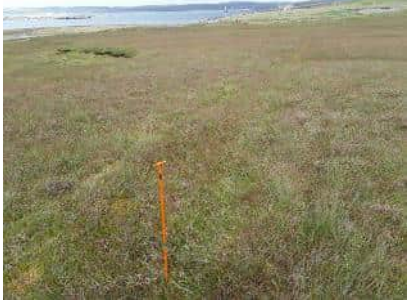
124	HU 41458 73938	Drainage ditch. Well vegetated. Ca. 20cm dip in ground surface. No clear effect on surrounding vegetation but could push walking pole down very easily compared with surrounding ground.

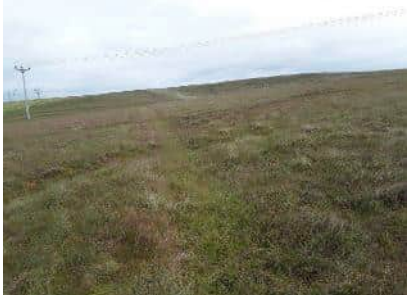
TG	Grid	Comment	Photo
125	HU 41429 74046	Water flowing along drainage line. Ca. 1m high edge. Perhaps old cutting?

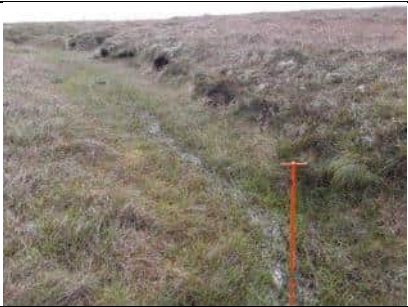
126	HU 41415 74094	Recent active peat cuttings. Ca. 1m deep. Ca. 10m long. Turf left at base.

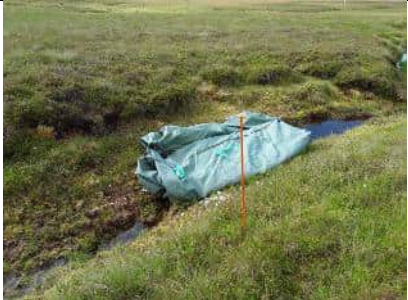
TG	Grid	Comment	Photo
130	HU 41350 74322	Large (ca. 5m wide) drain around field with M19a and spoil heaped at side with a little of U6.

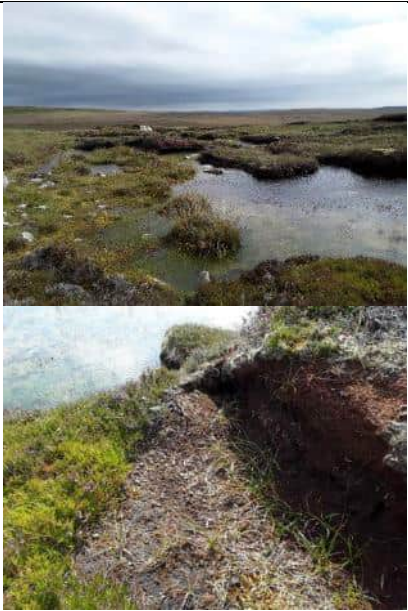
136	HU 41751 74693	Actively Eroding erosion feature ca. 1m high island remaining with bare peat around. Bare peat pan was ca. 5m x 30m with common cottongrass (M3) in areas going to U6 or M15c.

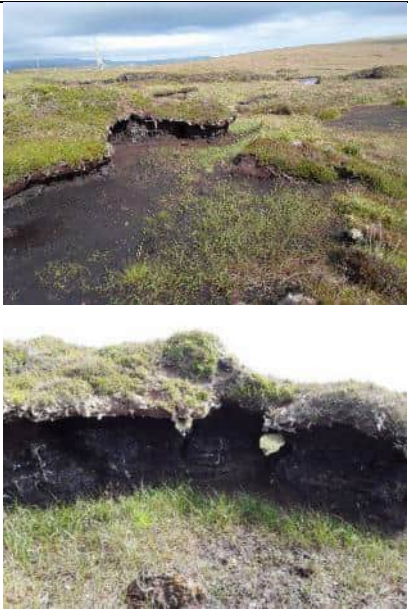
137	HU 41748 74683	View of Actively Eroding peat pan.

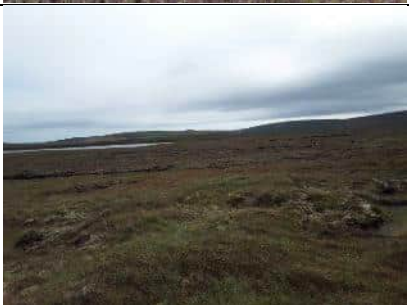
TG	Grid	Comment	Photo
142	HU 42069 74329	Large expanse of dry modified bog. Water draining through to Sand water. Woolly fringe moss dominated. Lots of exposed and Actively Eroding peat.

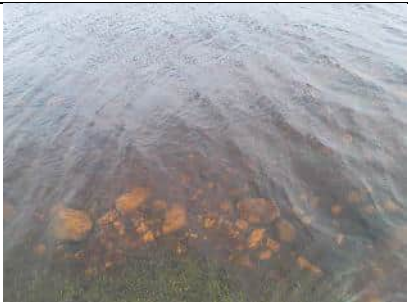
TG	Grid	Comment	Photo
146	HU 42154 74540	Drain and pipe going into Sand Water.

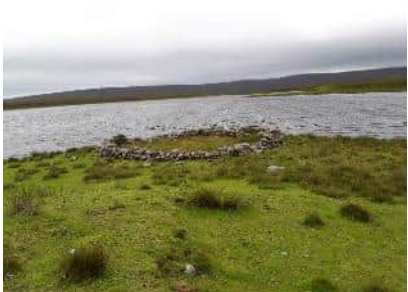
148	HU 42501 74826	High flows coming out of pipe into Sand Water. Likely draining bog. Brown stained. In MG10a.

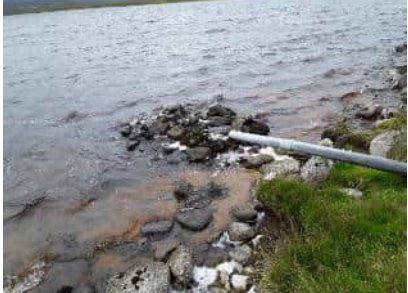
149	HU 42623 74768	Sand ca. 2m wide at the edge of Sand Water.

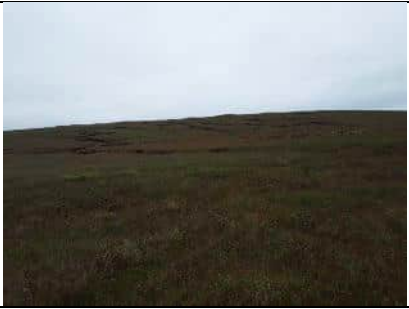
TG	Grid	Comment	Photo
150	HU 42661 74733	Series of erosion features going down slope. Ca. 1m deep.

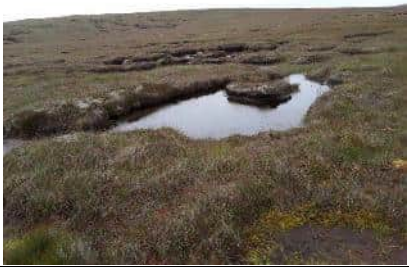
151	HU 42664 74665	Series of pools kept wet from surrounding erosion features. Evident of sheep impacts and not full carpet of bog-mosses. Modified (with elements of Near-Natural).

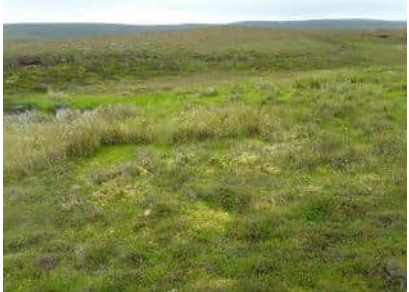
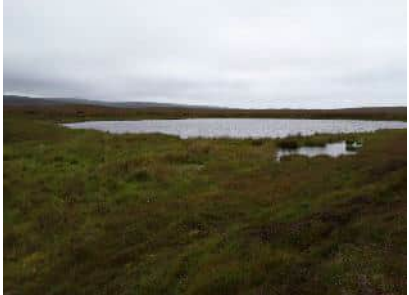
152	HU 42714 74547	Large area of M6c with pool by small unnamed lochan.

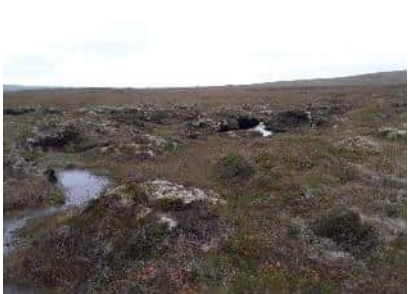
154	HU 42696 74349	There were ca. 1m deep erosion features in the dry modified bog with M3 and bare peat (70:20:10).

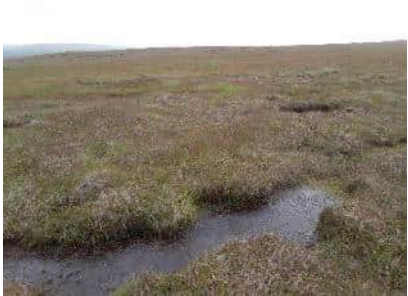
155	Hu 42660 74216	Example of Near-Natural blanket bog M17b:M2.

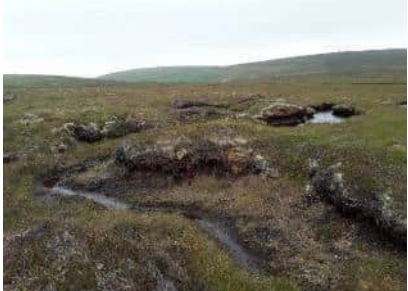
156	Hu 42684 74107	Dry modified bog with ca. 30cm to 1m high erosion features. Bare peat and M3 evident. Some pools present. Actively Eroding.

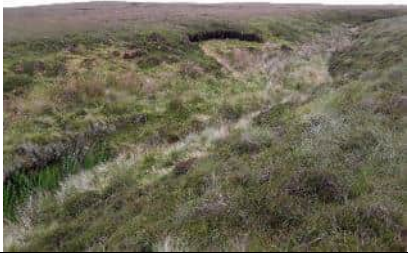
TG	Grid	Comment	Photo
157	Hu 42598 73986	Watercourse with M19a for ca. 5-10m leading up to the watercourse. Banks of watercourse H10a:U6:MG10a (50:30:20) with occasional yellow iris.

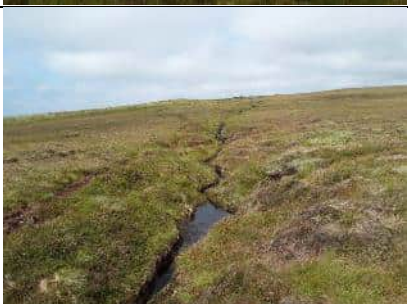
160	Hu 42406 73697	Likely old drainage ditch ca. 1.2m deep and 1m wide. Eroded and natural looking, but straight. Flowing at time of survey.

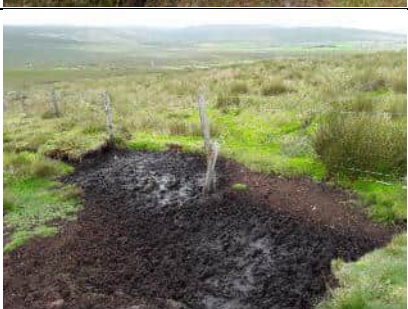
161	Hu 42326 73762	Fence ca. 1m off ground with erosion features around it. Field is U4 with soft rush in tussocks.

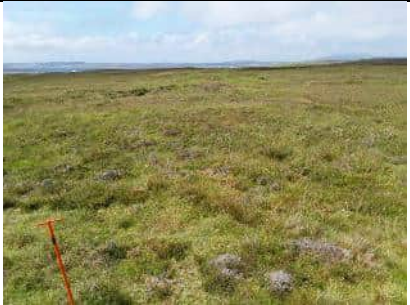
164	Hu 41925 73992	Large area of historic peat cuttings. Largely revegetated. M17b:M15c:U6:H10a at a ratio of 60:20:10:10. Drier areas were H10a with U6 at some bases, M15c on shallow soils and M17b where deep peat remained.

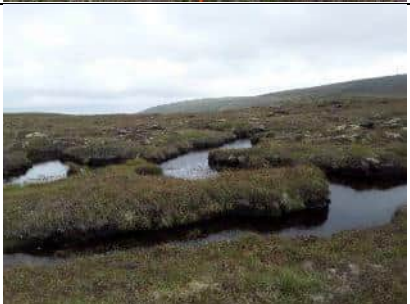
166	Hu 42787 73603	Dry modified bog with water filling bases of erosion features. M3 and bare peat present.

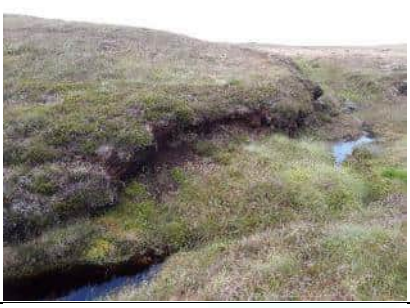
169	Hu 43046 73552	Dry heath beside a small M6b watercourse. Erosion along sides was ca. 0.5m to 1m deep.

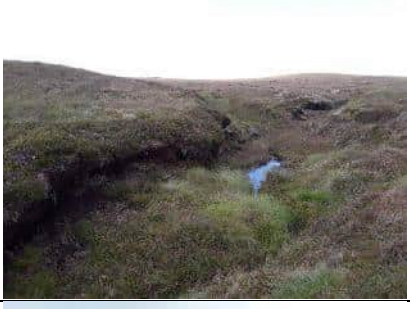
170	Hu 42581 77536	Example erosion feature in dry modified bog. Ca 1m deep some M3 and bare peat.

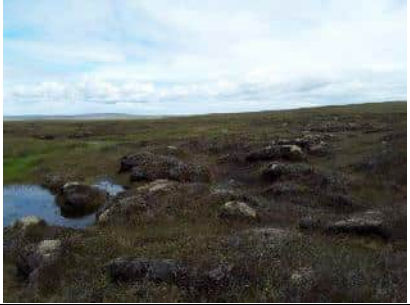
173	HU 41962 78205	Mixture of DMB:M6:M3:M2. Some bog-moss filled pools others Actively Eroding. Transition between Near-Natural and Actively Eroding.

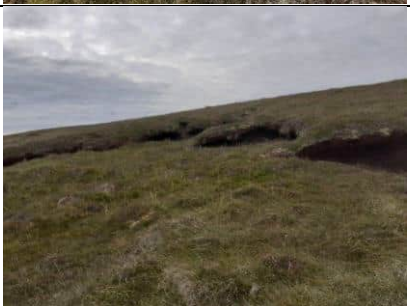
176	HU 42337 75800	Possible old peat cutting. Ca 10m x 20m. Mix of H10a and M17b at base.

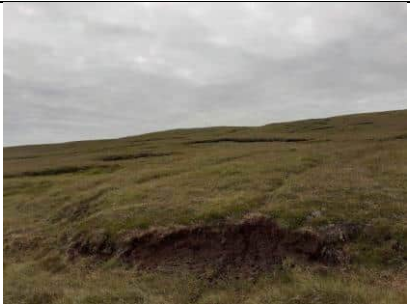
181	HU 42329 76279	Large area of historic peat cuttings. Ca. 0.5m deep. Vegetation at base and top but bare peat exposed and Actively Eroding in places.

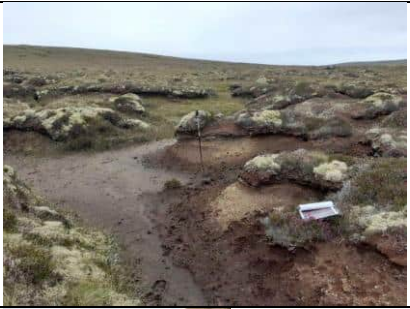
TG	Grid	Comment	Photo
183	HU 42762 74655	Heavily eroded dry modified bog. Erosion features ca. 1m deep. Bare peat was ca. 30-40% cover at this location.

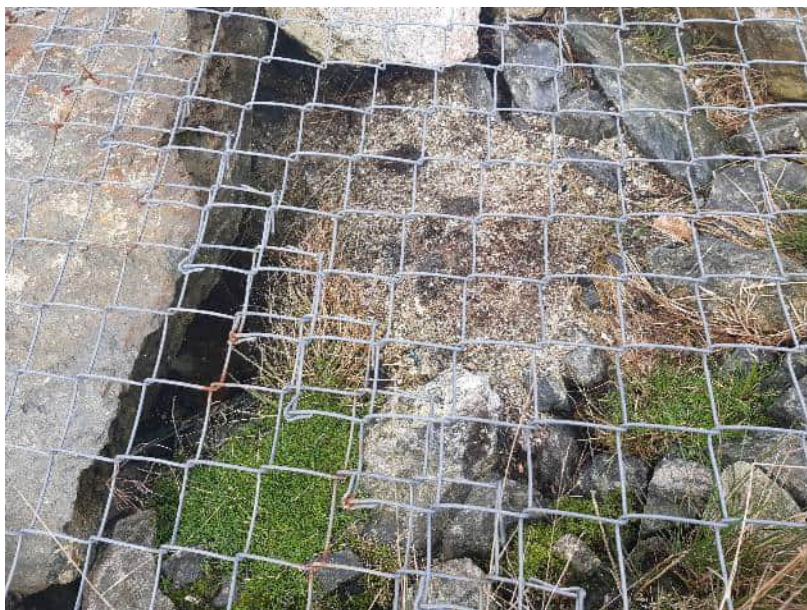
**Photo 1:** Active otter holt at HU 40940 77604.

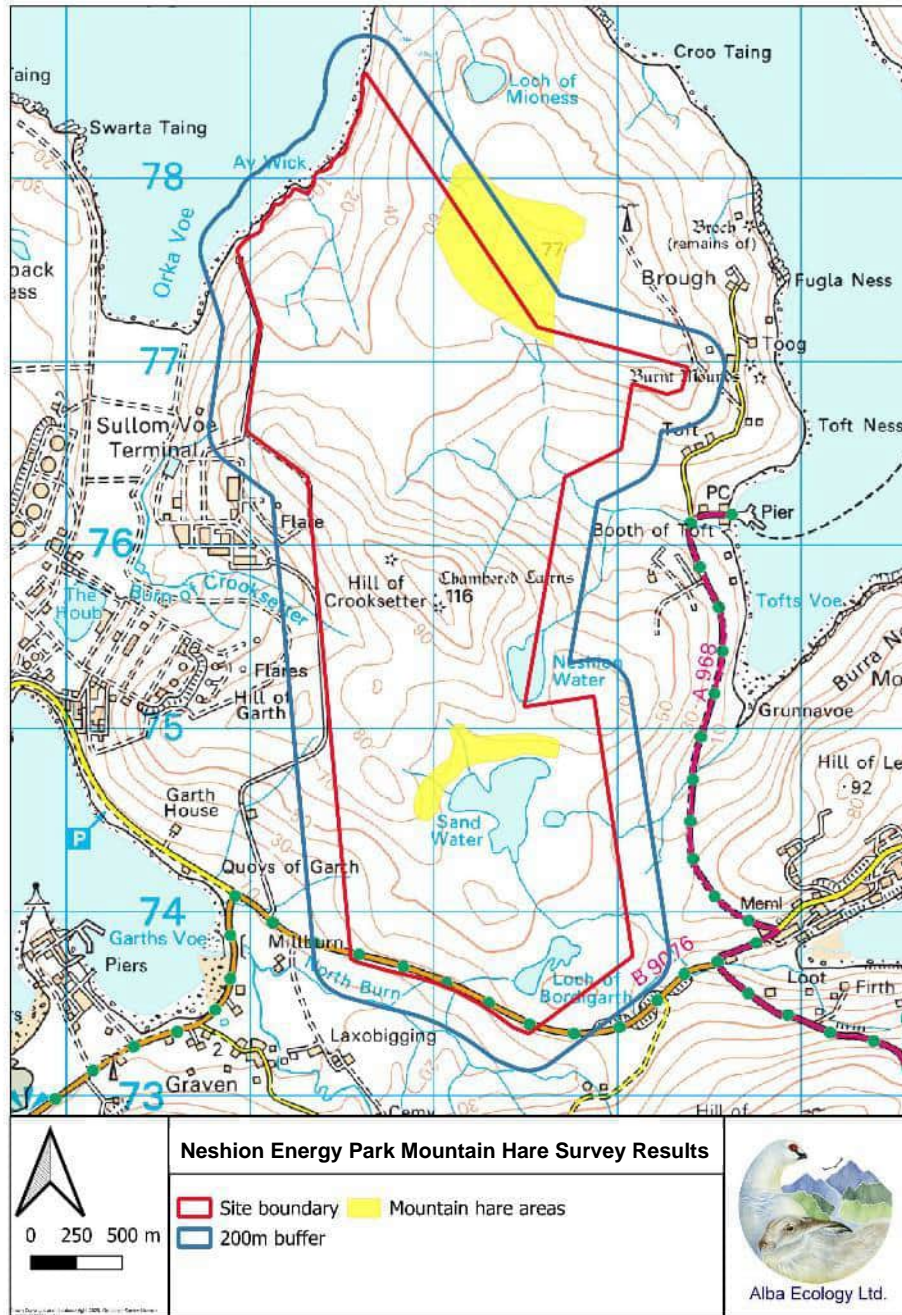
**Figure 3:** Areas of high mountain hare occurrence/activity.

Two parts of the Study Area had a notably higher incidence of sightings of mountain hare. most being recorded within 200-300m of the northern side of Sand Water and at the northern edge of the Study Area (Figure 3). This was breeding behaviour, with several males pursuing females in both 2023 and 2024. In one case mating was observed in the Study Area in 2023.

Whilst Figure 3 highlights areas of relatively high abundance during 2023-2024, mountain hare populations demonstrate large fluctuations or population cycles with an average periodicity of nine years (range four-fifteen years). Population density can change more than ten-fold over such a cycle (Newey *et al.*, 2007). Therefore, it is important to recognise that the areas of
