## Technical Appendix 6.6: Peatland Habitat Restoration Opportunities for Neshion Energy Park

## Annex 1: Target Notes

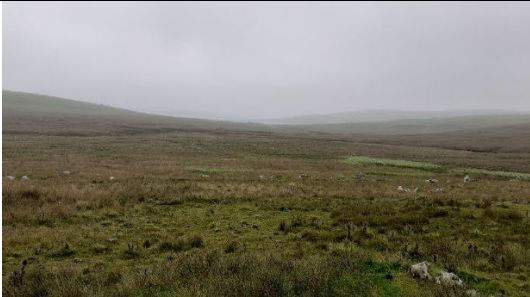
| No. | Grid | Note | Illustrative photo |
|---|---|---|---|
| 1 | HU<br>42383<br>76378. | Downslope from sheiling. Potential site for new a new wader-pool in thick rushy sward. Might attract breeding black-tailed godwit, a high priority species. | |

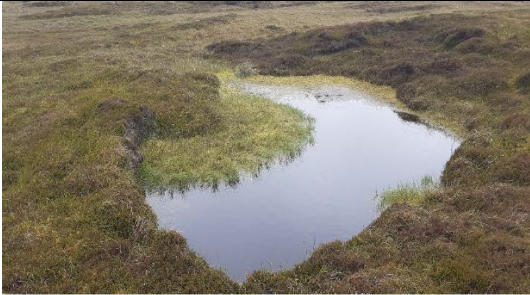
| No. | Grid | Note | Illustrative photo |
|---|---|---|---|
| 2 | HU<br>42226<br>76831 | Potential bog pool restoration through permanent rewetting. Block far end of pool to stop water leaving and flowing downslope. | |

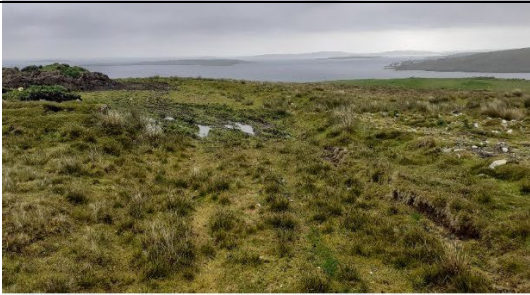
| No. | Grid | Note | Illustrative photo |
|---|---|---|---|
| 3 | HU<br>43318<br>76894 | Area by existing silage dump potentially suitable for a new wader-scrape. | |

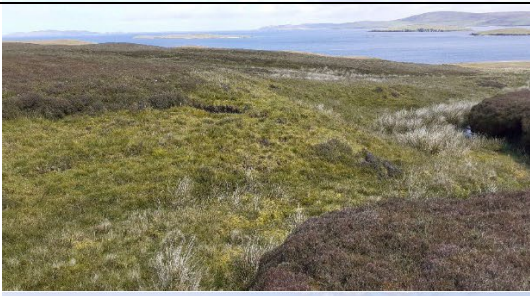
| No. | Grid | Note | Illustrative photo |
|---|---|---|---|
| 4 | HU<br>42876<br>77991 | Grassy riparian corridor potentially suitable for scrub planting. c. 100m in length, 5-10m wide and 1-2m deep height from mineral soil base to adjacent blanket bog surface. Planting possible on non-blanket bog habitats. | |

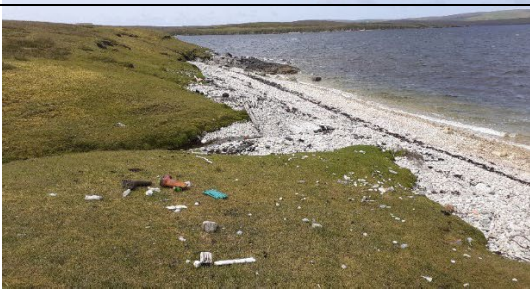
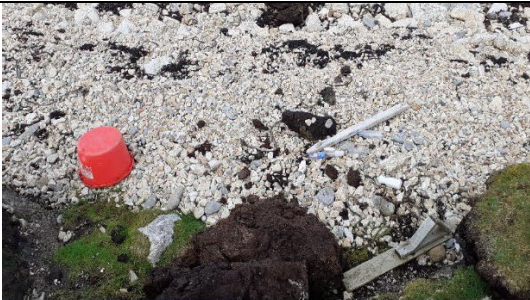
| No. | Grid | Note | Illustrative photo |
|---|---|---|---|
| 5 | HU<br>41440<br>78049 | Lots of plastic debris along SAC shoreline in Ay Wick (Orka Voe), within c. 20m of otter holt. Could be cleared up regularly as part of biodiversity enhancement. Old fishing nets and pots washed up etc. could pose threat to birds and otters. | |

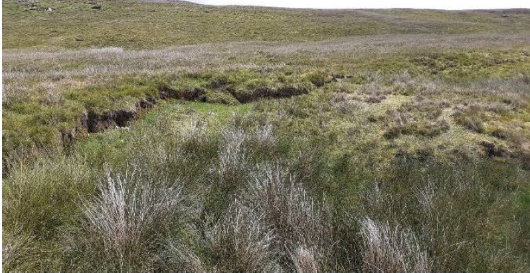
| No. | Grid | Note | Illustrative photo |
|---|---|---|---|
| 6 | HU<br>41459<br>78022 | Location for artificial otter holt. Small unnamed burn runs down slope and enters sea c. 50m from where new holt proposed. Lots of other potential locations present. | |

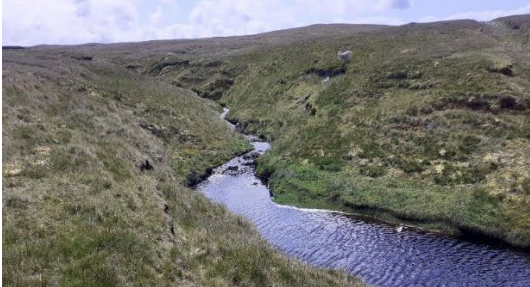
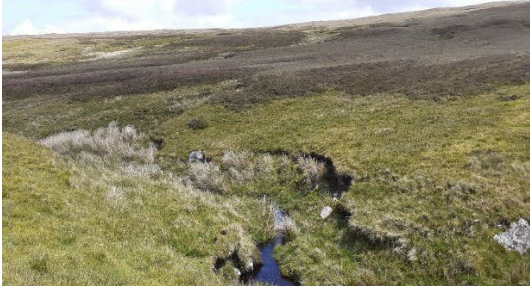
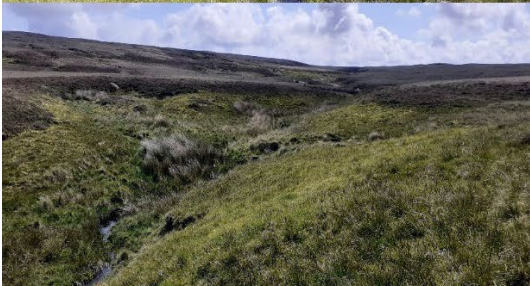
| No. | Grid | Note | Illustrative photo |
|---|---|---|---|
| 7 | HU<br>41317<br>77865 | Potential riparian broadleaved planting along watercourse corridor, starting 20m up from beach. Corridor heading upstream into sheltered valley from prevailing wind direction. c. 5-10m wide corridor, potentially planting scrub on both sides of this small unnamed burn. | |

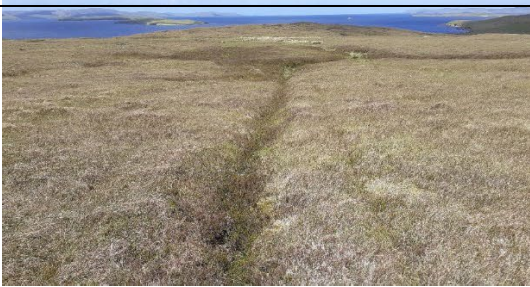
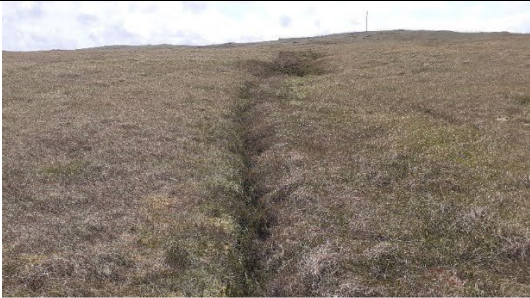
| No. | Grid | Note | Illustrative photo |
|---|---|---|---|
| 8 | HU<br>41210<br>77183 | Example photos of linear ditch feature, suitable for blocking. Although vegetated, still clearly drying out and adversely affecting surrounding bog habitat. Photos taken up and downslope from this location. Restoration potential. Other ditches exist and these | |

| No. | Grid | Note | Illustrative photo |
|---|---|---|---|
| | | photos are illustrative of these potential restoration features. | |

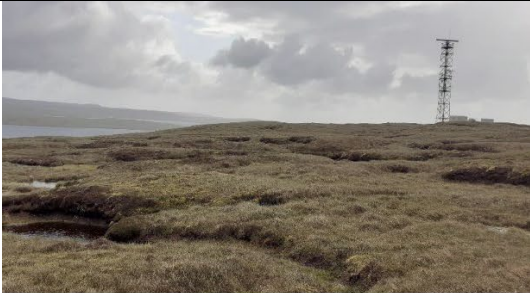
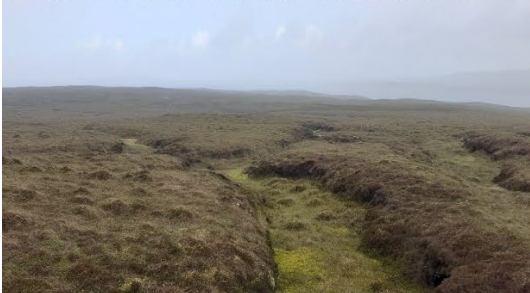
| No. | Grid | Note | Illustrative photo |
|---|---|---|---|
| 9 | HU<br>42673<br>77777 | Extensive area of peat hags near mast. Off-site, but recommend including. Some surface pools, but lots of erosion and bare peat. Hags typically 1m deep, 5-10m in length, some vegetated, some not. Restoration potential. | |

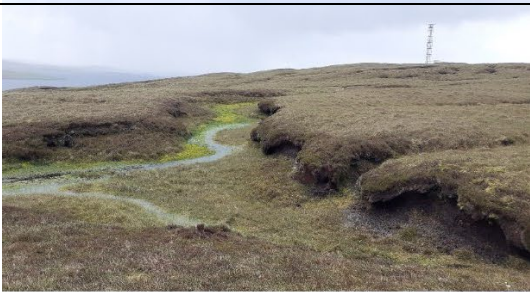
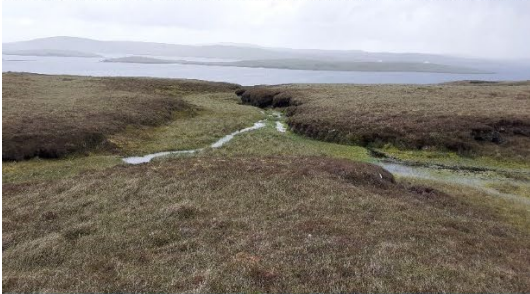
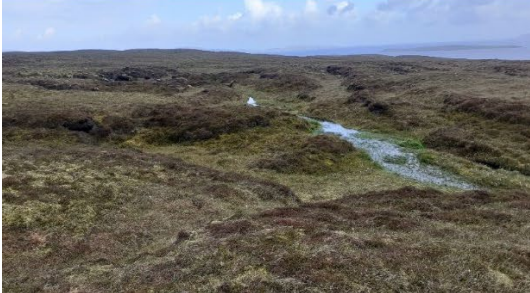
| No. | Grid | Note | Illustrative photo |
|---|---|---|---|
| 10 | HU<br>42776<br>77902 | Three large erosion channels joint together here. These photos were taken looking east, north and west from this grid reference. At confluence c. 20m wide, 2m deep, with undercut blanket bog edges. The undercut edges created/used by sheep sheltering based on amount of wool present on heather overhangs. Restoration potential. | |

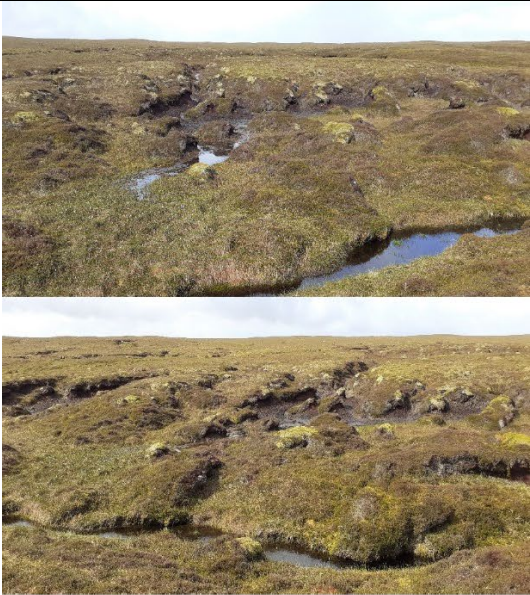
| No. | Grid | Note | Illustrative photo |
|---|---|---|---|
| 11 | HU<br>427751<br>77951 | Hagging extends in a westerly direction. Restoration potential throughout this very large, heavily eroded area. | |

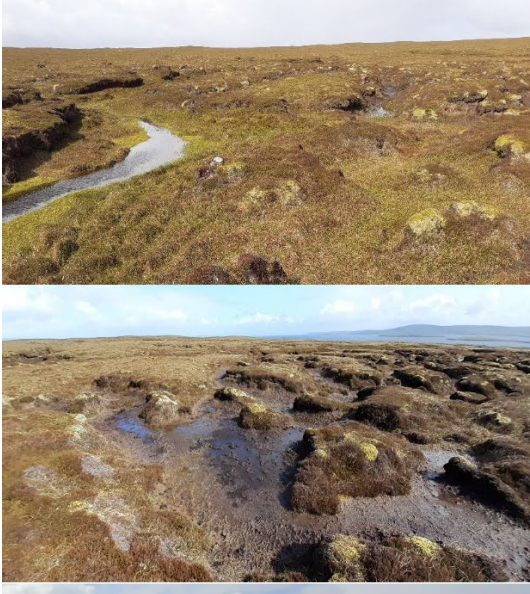
| No. | Grid | Note | Illustrative photo |
|---|---|---|---|
| 12 | HU<br>42702<br>77900 | Gully (4-10m wide, 1-2m deep) and extensive hagging. Edges unvegetated, lots of bare peat and clearly continually damaged by sheep looking for shelter. Restoration potential. | |

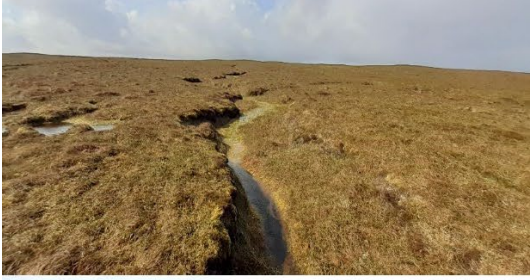
| No. | Grid | Note | Illustrative photo |
|---|---|---|---|
| 13 | HU<br>42601<br>77817 | Extent of wide gully in this area. Restoration potential. | |

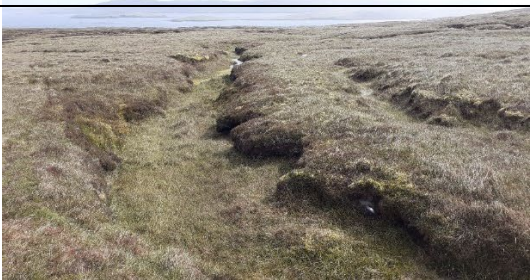
| No. | Grid | Note | Illustrative photo |
|---|---|---|---|
| 14 | HU<br>42614<br>77767 | Vegetated gully, with lots of bare hagged edges from sheltering sheep. Although gully base well vegetated, still draining surrounding blanket bog habitat, so needs blocking/infilling. Restoration potential. | |

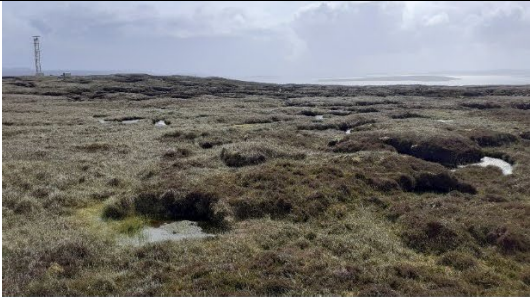
| No. | Grid | Note | Illustrative photo |
|---|---|---|---|
| 15 | HU<br>42732<br>77594 | Large extensive area of haggging, typically 1-2m deep. Restoration potential in this area. | |

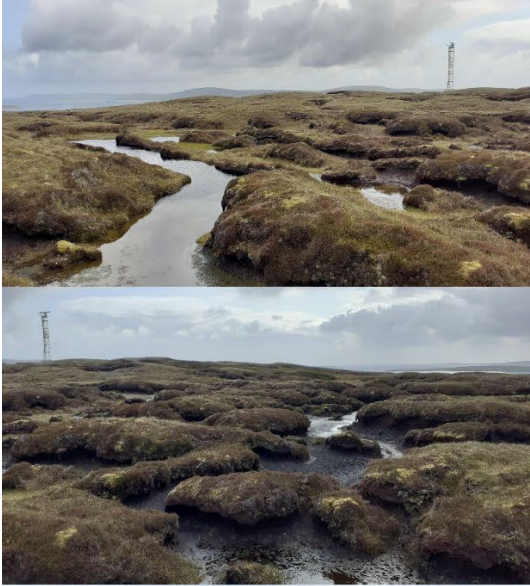
| No. | Grid | Note | Illustrative photo |
|---|---|---|---|
| 16 | HU<br>42819<br>77604 | In the heart of extensive hagged area, with many erosion gullies >2m deep. Some with standing water and vegetated with a little <i>Sphagnum</i> but many just bare peat. Restoration potential. | |

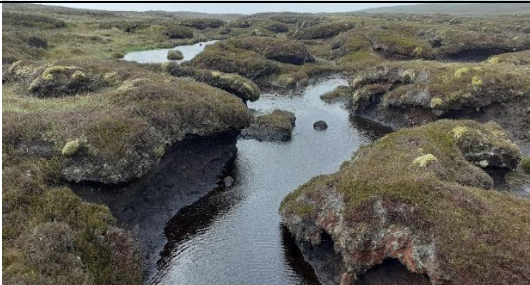
| No. | Grid | Note | Illustrative photo |
|---|---|---|---|
| 17 | HU<br>42857<br>77606 | Some of the largest hags >3m deep from vegetated edge to base. Restoration potential. | |

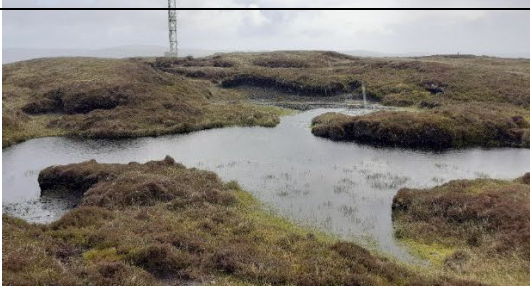
| No. | Grid | Note | Illustrative photo |
|---|---|---|---|
| 18 | HU<br>42892<br>77633 | Hags close to mast very deep (c. 3m) and extensive. Some pools vegetated with <i>Sphagnum</i> but most not, just bare peat with shallow water. Restoration opportunities. | |

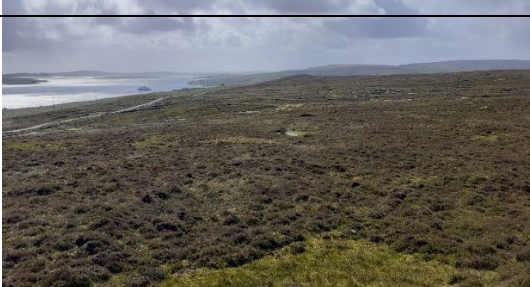
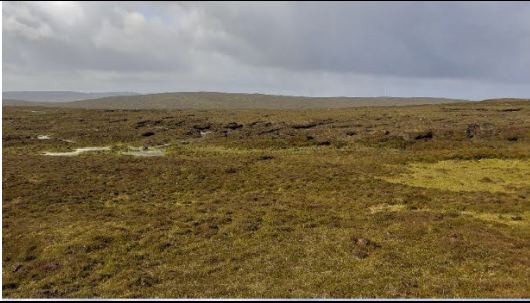
| No. | Grid | Note | Illustrative photo |
|---|---|---|---|
| 19 | HU<br>42964<br>77610 | Looking south towards ferry terminal from near mast. Some hags in distance and the occasional shallow gully. Restoration potential. | |

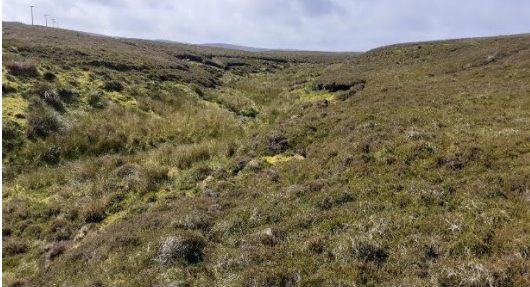
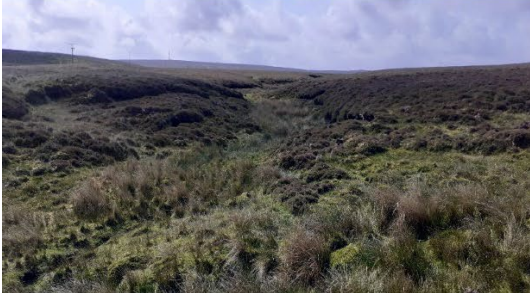
| No. | Grid | Note | Illustrative photo |
|---|---|---|---|
| 20 | HU<br>43308<br>74625 | Riparian planting opportunity. Left channel, parallel to main road. Riparian broadleaved scrub planting potential. Two channels meet here, and both hold suitable grass/rushy riparian habitats for c. 150m upstream from this location c. 5-10m wide and sheltered from prevailing wind direction. | |

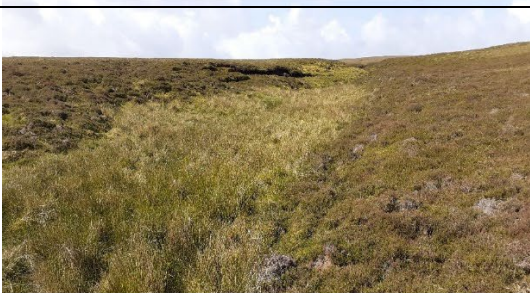
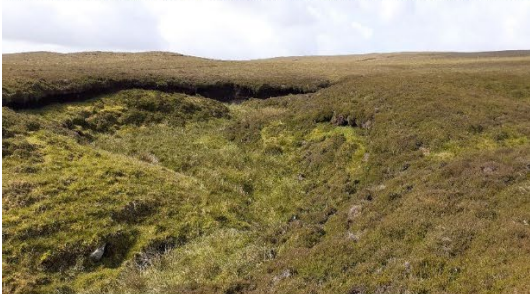
| No. | Grid | Note | Illustrative photo |
|---|---|---|---|
| 21 | HU43157<br>74474 | Right-hand channel, suitable from riparian scrub. Planting could go up to c. HU 43096 74491 if no deep peat present. | |

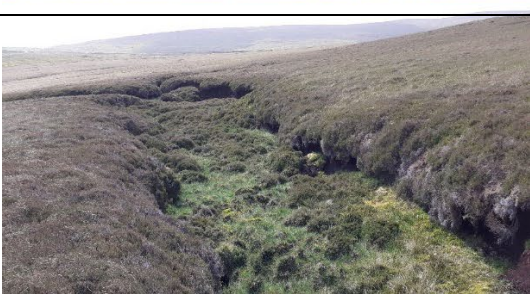
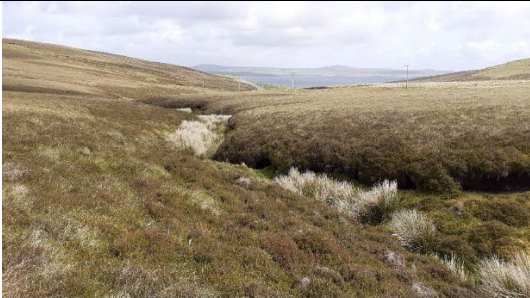
| No. | Grid | Note | Illustrative photo |
|---|---|---|---|
| 22 | HU<br>43234<br>74348 | Extent of suitable habitat for riparian planting along left channel. However, only potentially suitable, need to avoid deep peat areas. | |

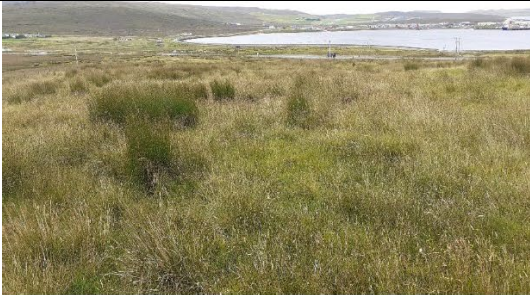
| No. | Grid | Note | Illustrative photo |
|---|---|---|---|
| 23 | HU<br>41279<br>74287 | Reseeded grass field, with rushes. Potential for a small wader pool/scrape. | |

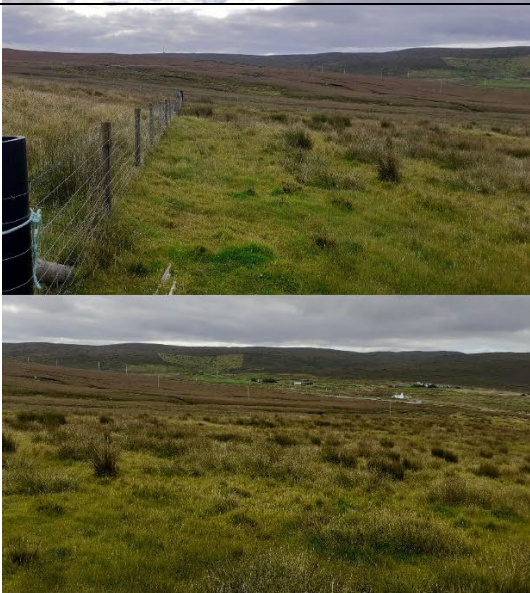
| No. | Grid | Note | Illustrative photo |
|---|---|---|---|
| 24 | HU<br>42067<br>73932 | Reseeded grass field. Two potential options. Firstly, create a small wader pool/scrape to help bolster local breeding waders. Or secondly, the field is in a peatland dominated landscape and it is possible the reseeded and liming have changed its surface vegetation only but underlying it lies intact deep peat. If so, could try to restore blanket bog habitats as part of ambitious peatland restoration plans. | |

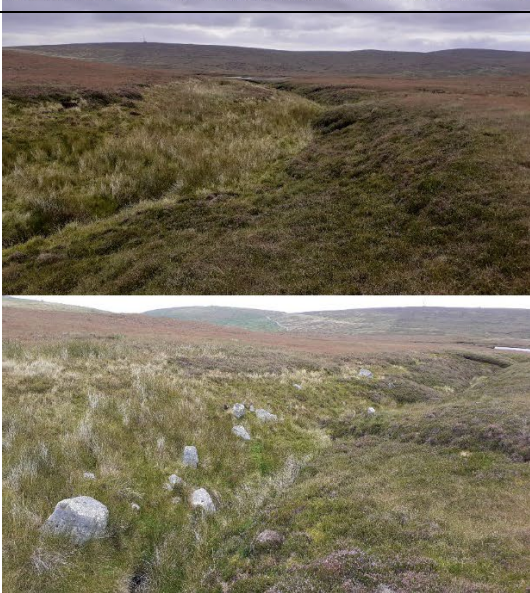
| No. | Grid | Note | Illustrative photo |
|---|---|---|---|
| 25 | HU<br>42425<br>74207 | Burn of Sandwater. Some of riparian habitat is suitable for native broadleaved scrub planting. | |

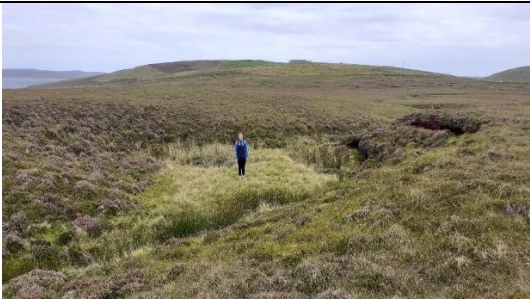
| No. | Grid | Note | Illustrative photo |
|---|---|---|---|
| 26 | HU<br>42918<br>73958 | Burn of Sandwater. Some potentially suitable riparian habitats for native broadleaved scrub planting. | |

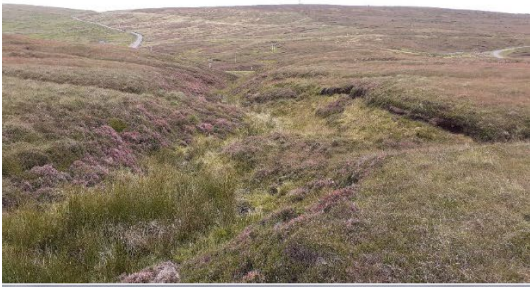
| No. | Grid | Note | Illustrative photo |
|---|---|---|---|
| 27 | HU<br>43171<br>73899 | Burn of Sandwater. Some suitable riparian habitats for native broadleaved scrub planting. | |

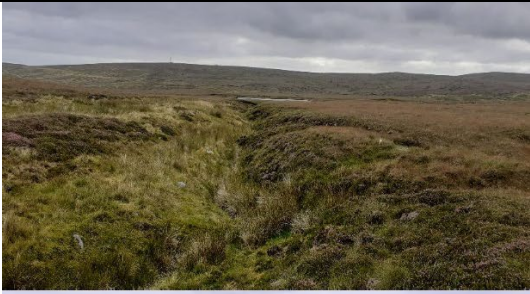
| No. | Grid | Note | Illustrative photo |
|---|---|---|---|
| 28 | HU<br>42436<br>74168 | Burn of Sandwater. Some suitable riparian habitats for native broadleaved scrub planting. | |

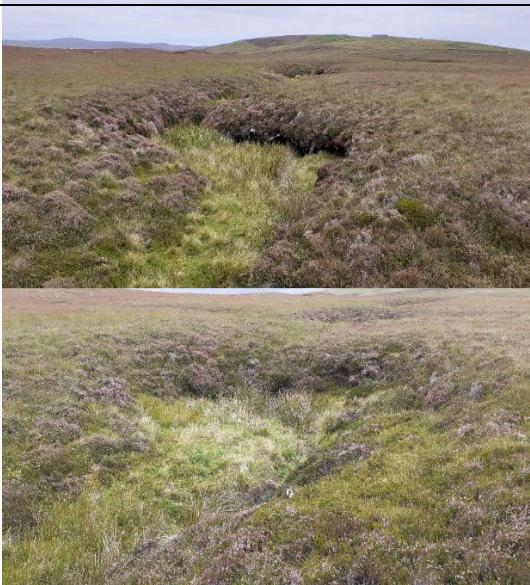
| No. | Grid | Note | Illustrative photo |
|---|---|---|---|
| 29 | HU<br>42646<br>73905 | Burn of Sandwater. Some potentially suitable riparian habitats for native broadleaved scrub planting. Variable width, sometimes the Burn of Sandwater disappears for e.g. 25m before reappearing again as @ HU 42748 73906. | |

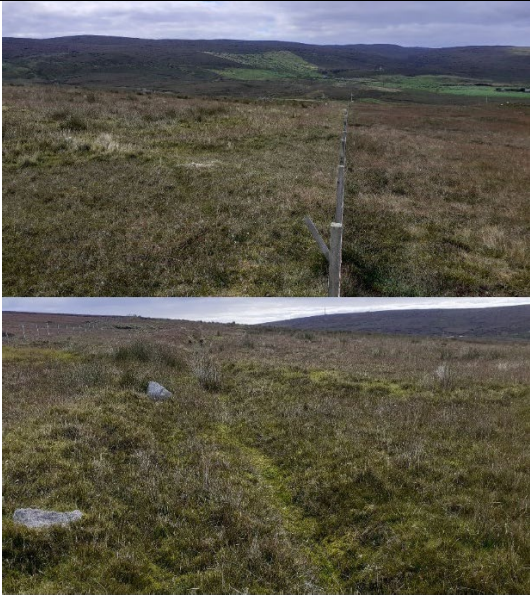
| No. | Grid | Note | Illustrative photo |
|---|---|---|---|
| 30 | HU<br>42085<br>73918 | Fenceline grazing effects. Note the reseeded grass field in a peatland landscape in the far distance to illustrate how incongruous such fields are. Drainage ditch (vegetated) running across the field. Could be blocked if restoring field to its original peatland habitat. | <p>The top photograph shows a wide, vegetated drainage ditch running across a grassy field. In the far distance, a reseeded grass field is visible, contrasting with the surrounding peatland landscape. The bottom photograph shows a similar view of a grassy field with a drainage ditch, highlighting the incongruity of the reseeded field in the distance.</p> |

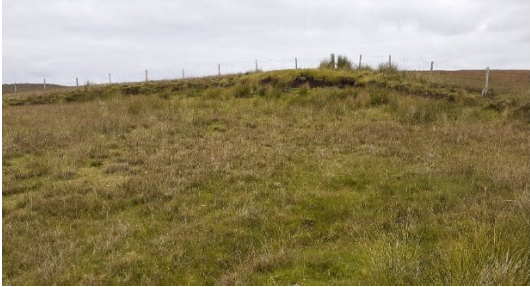
| No. | Grid | Note | Illustrative photo |
|---|---|---|---|
| 31 | HU<br>42251<br>73859 | Potential for small wader pool/scrape in depression in the corner of this grassy field. | <p>The photograph shows a grassy field with a small depression in the corner, which is identified as a potential site for a small wader pool or scrape. The field is surrounded by a fence line.</p> |
